Shire of  
**Narrogin**  
*Love the life*

## BRIDGES ASSET MANAGEMENT PLAN

2020-2030

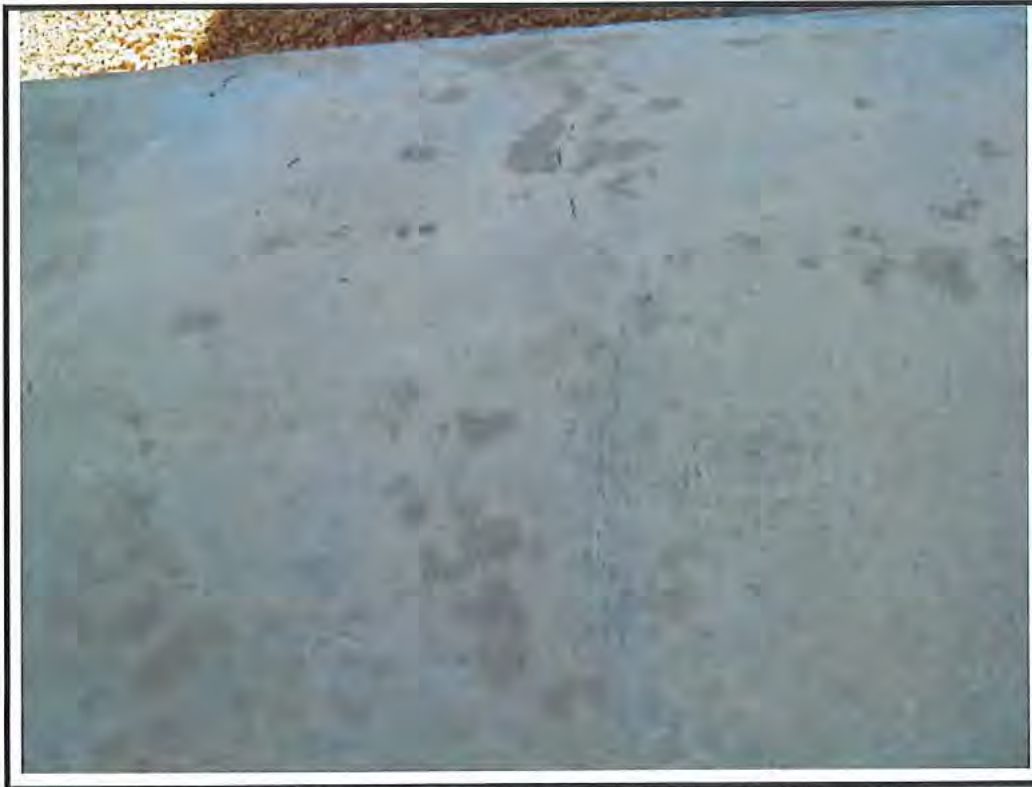
Photo No. 27: cracking to surface concrete – Pier 2

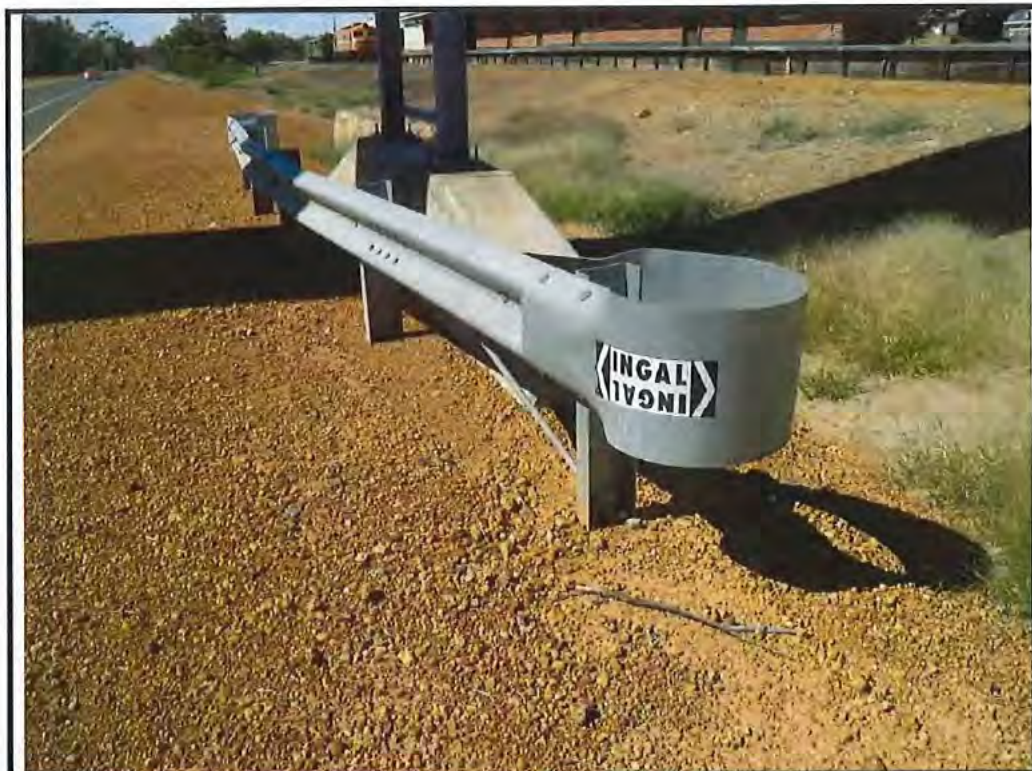
Photo No. 28: Inadequate pier protection – Pier 2

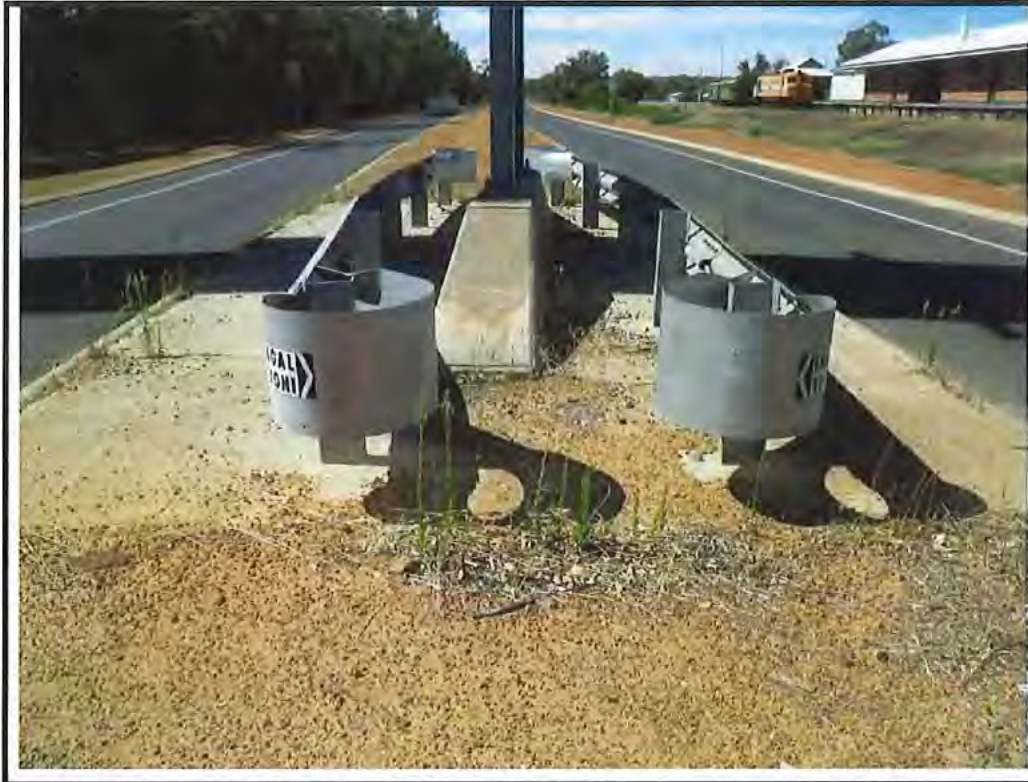
Photo No. 29: Inadequate pier protection – Pier 3

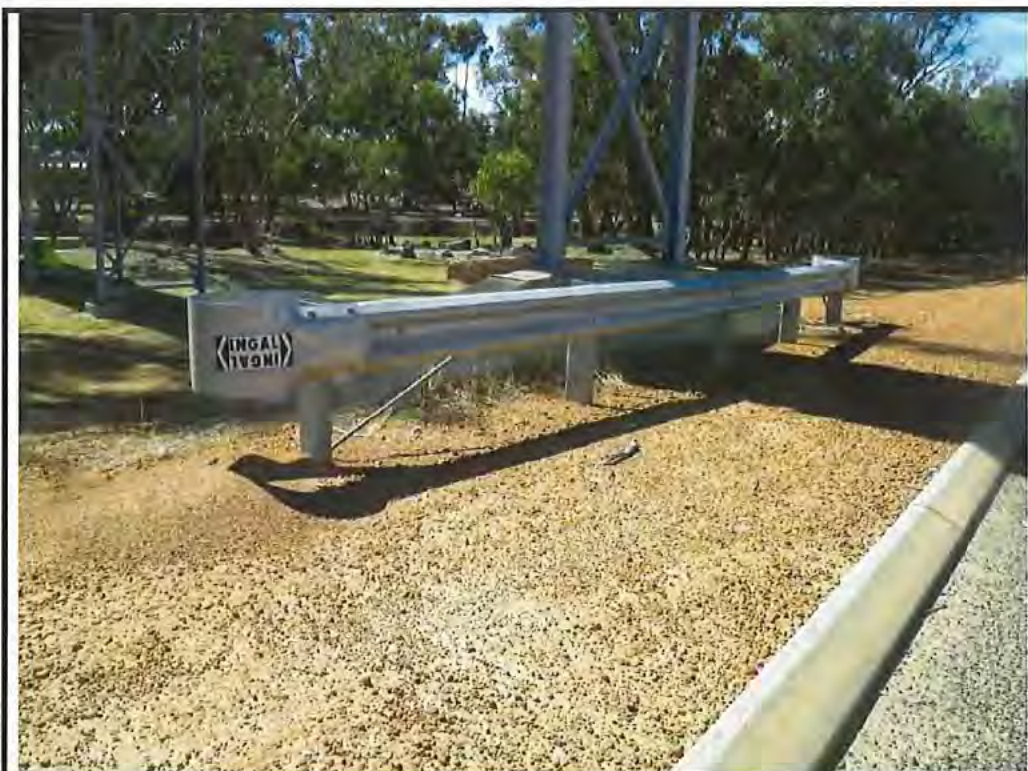
Photo No. 30: Inadequate pier protection – Pier 4

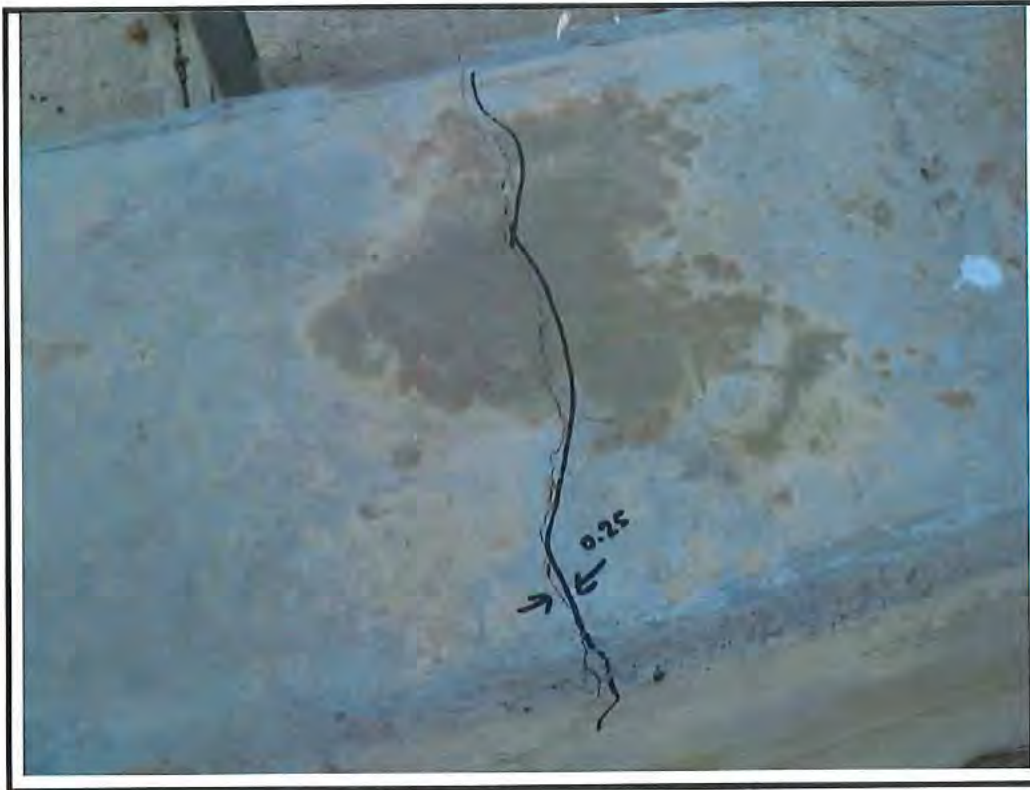
Photo No. 31: cracking to concrete surfacing Pier 3

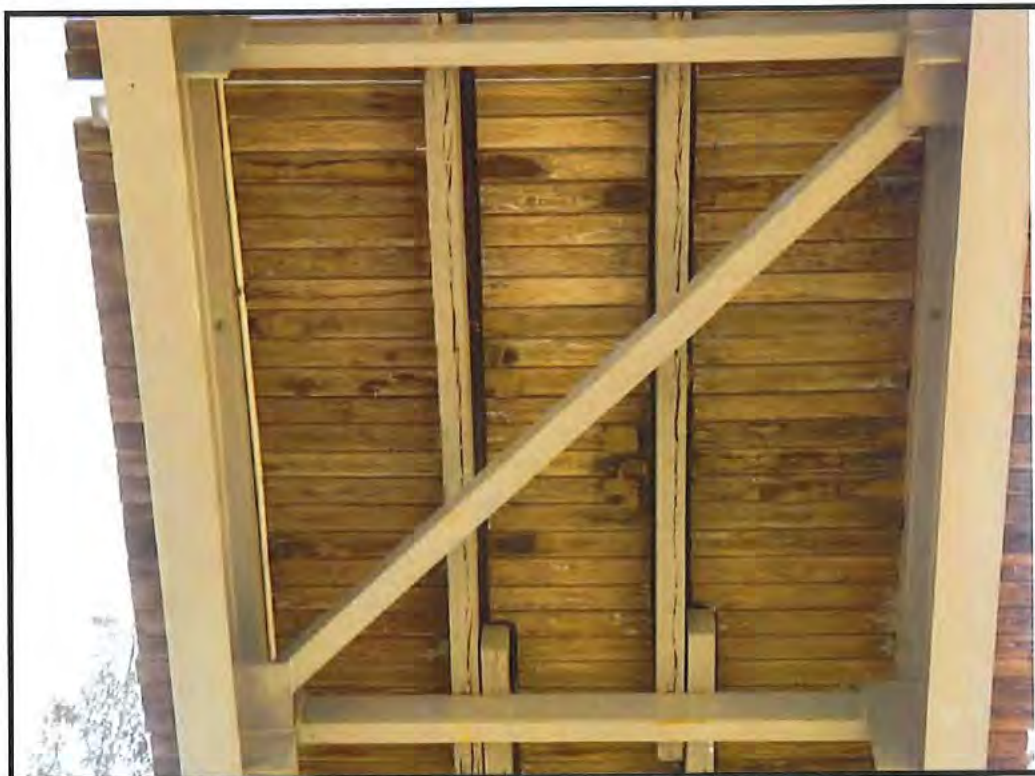
Photo No. 32: Timber bearing split

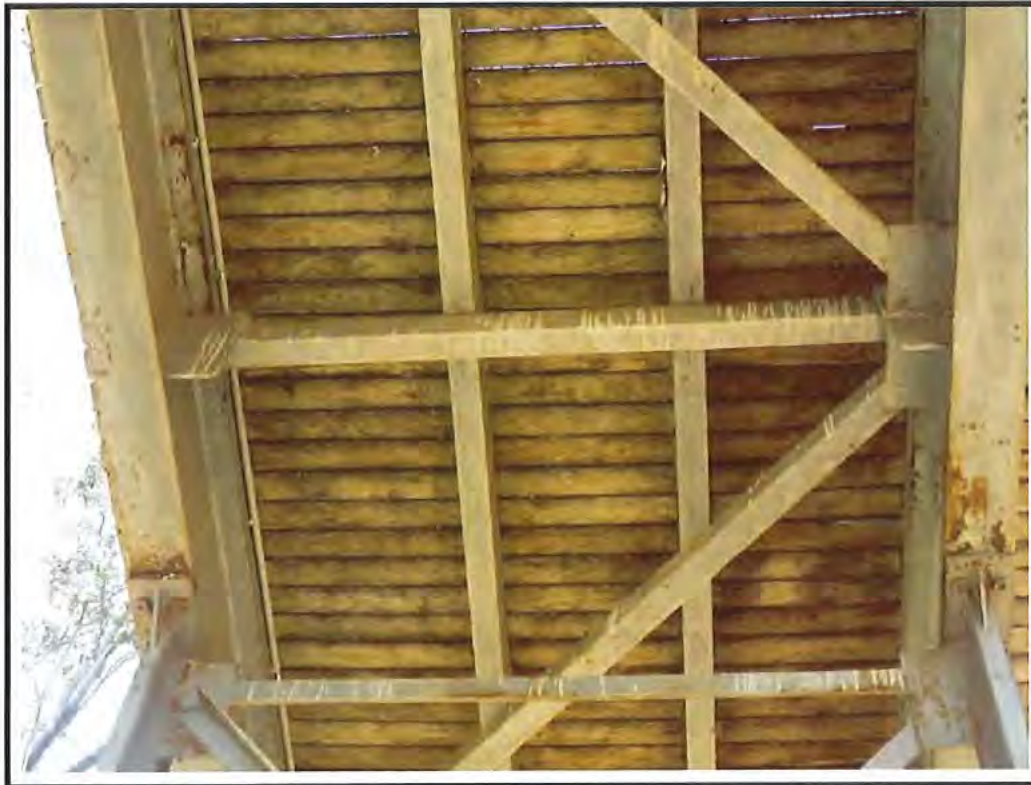
Photo No. 33: Minor surface corrosion common throughout

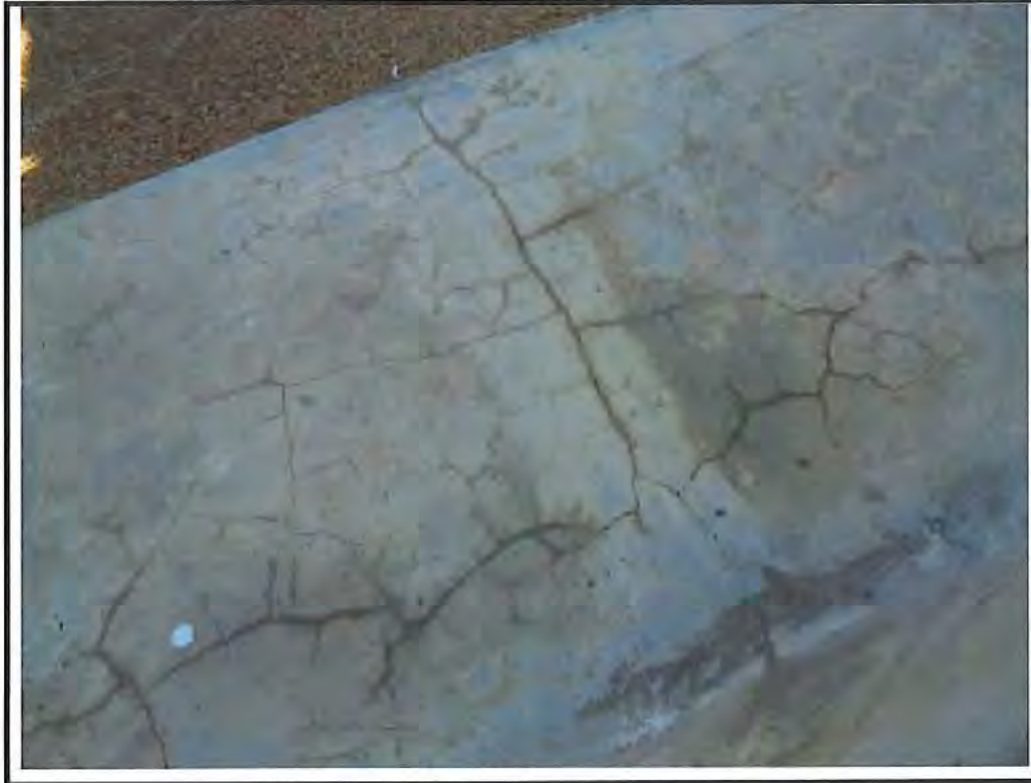
Photo No. 35: cracking to concrete 4

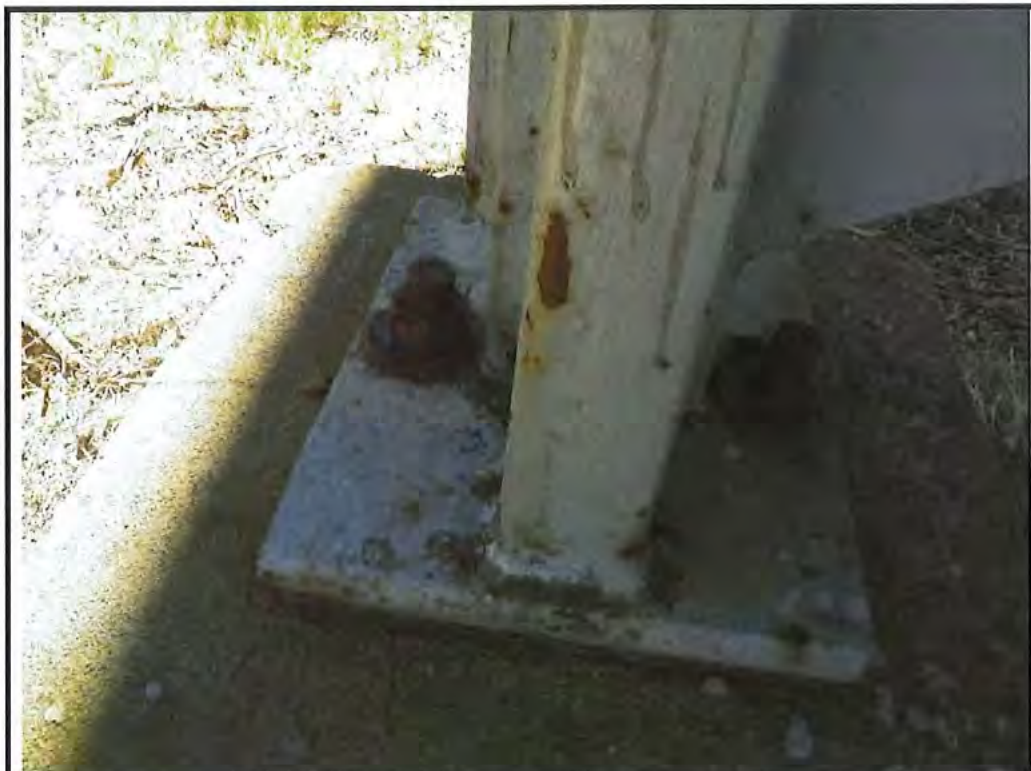
Photo No. 36: Bolts Pier 7 badly corroded – sheared off

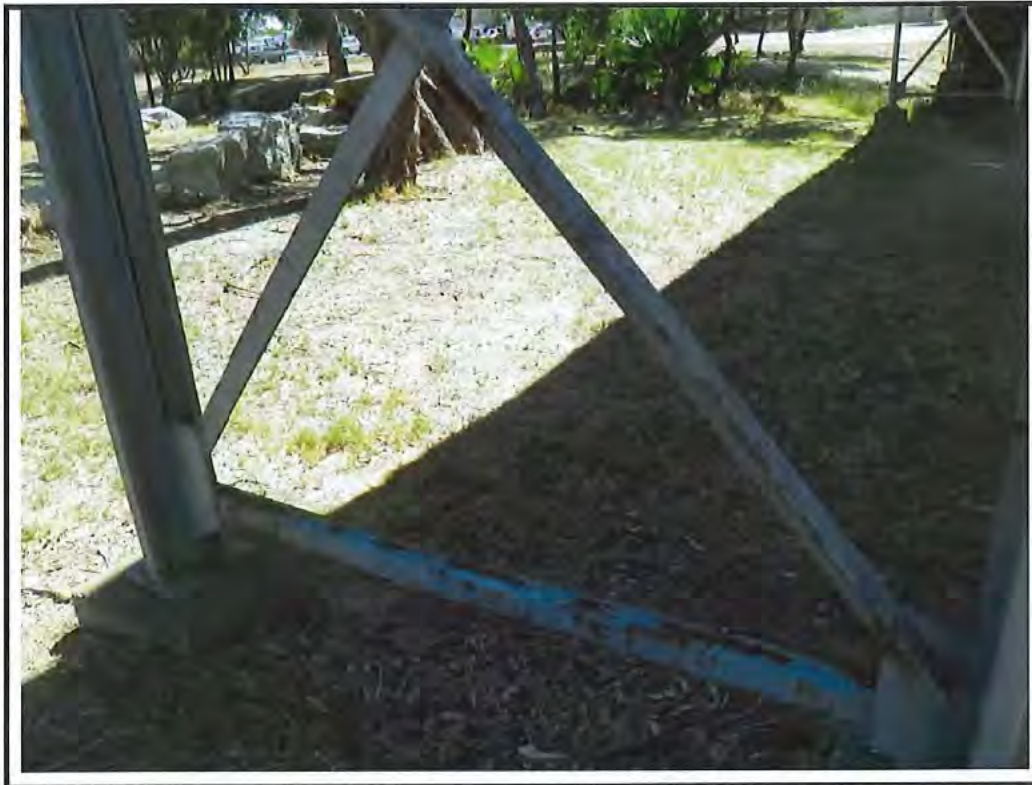
Photo No. 37: Typical surface corrosion to Piers

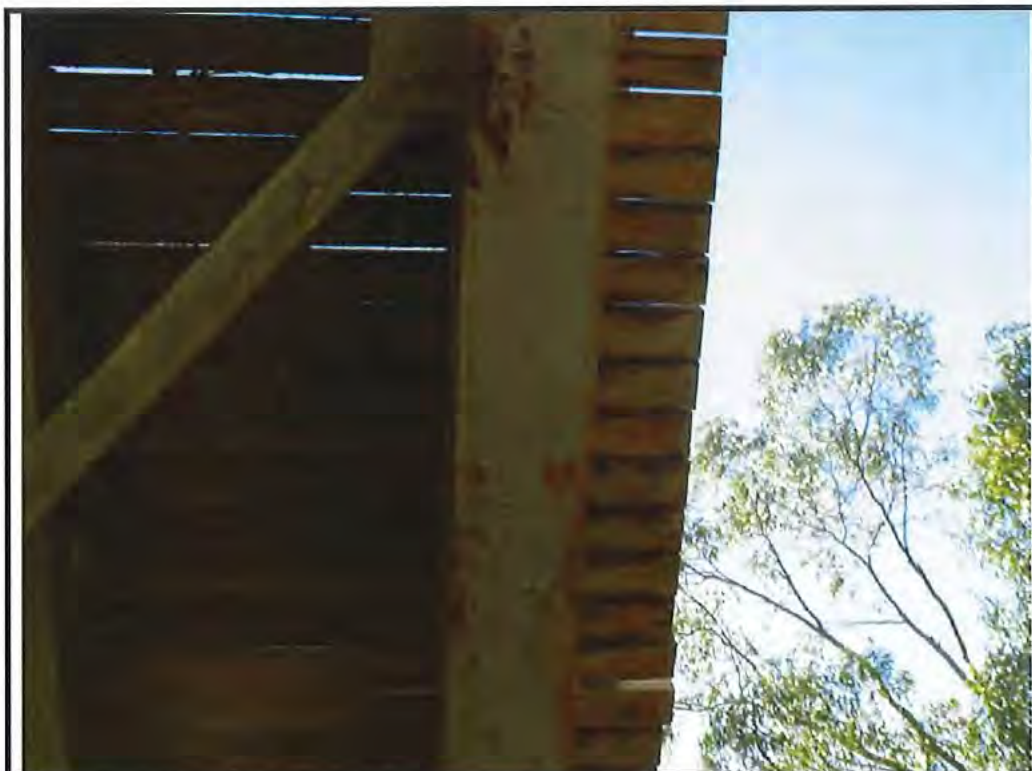
Photo No. 38: Minor surface corrosion to beams - typical

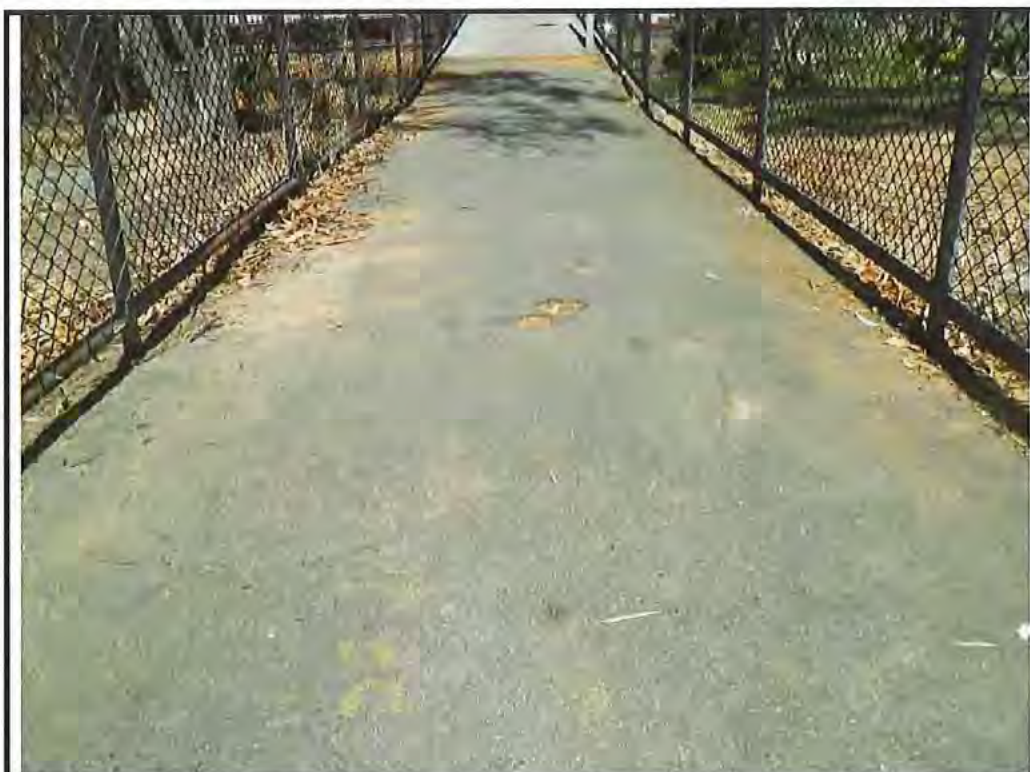
Photo No. 44: Surfacing A2 cracked

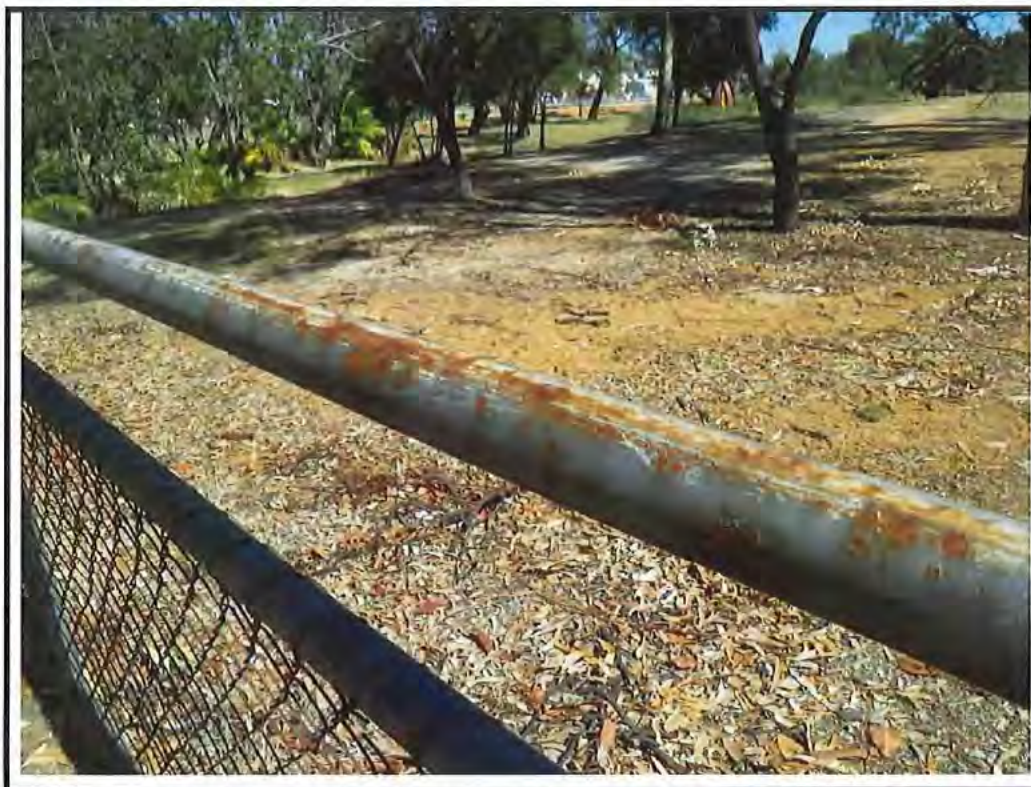
Photo No. 45: Rusting to approach 2 rails

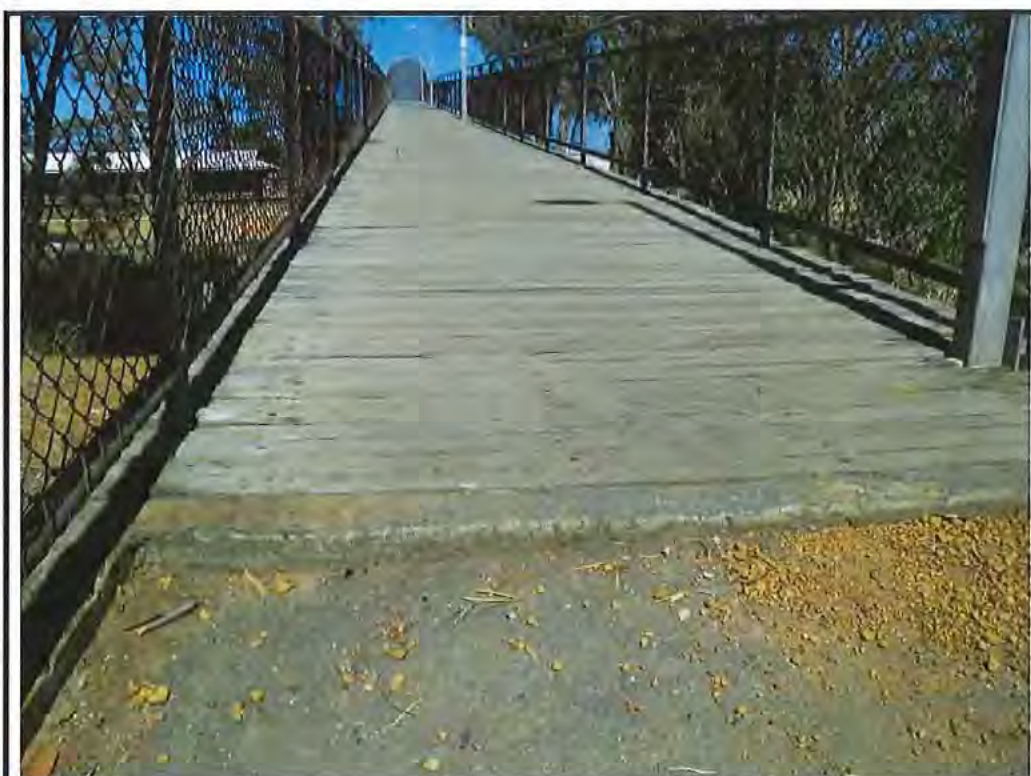
Photo No. 46: Minor trip hazard A2 end

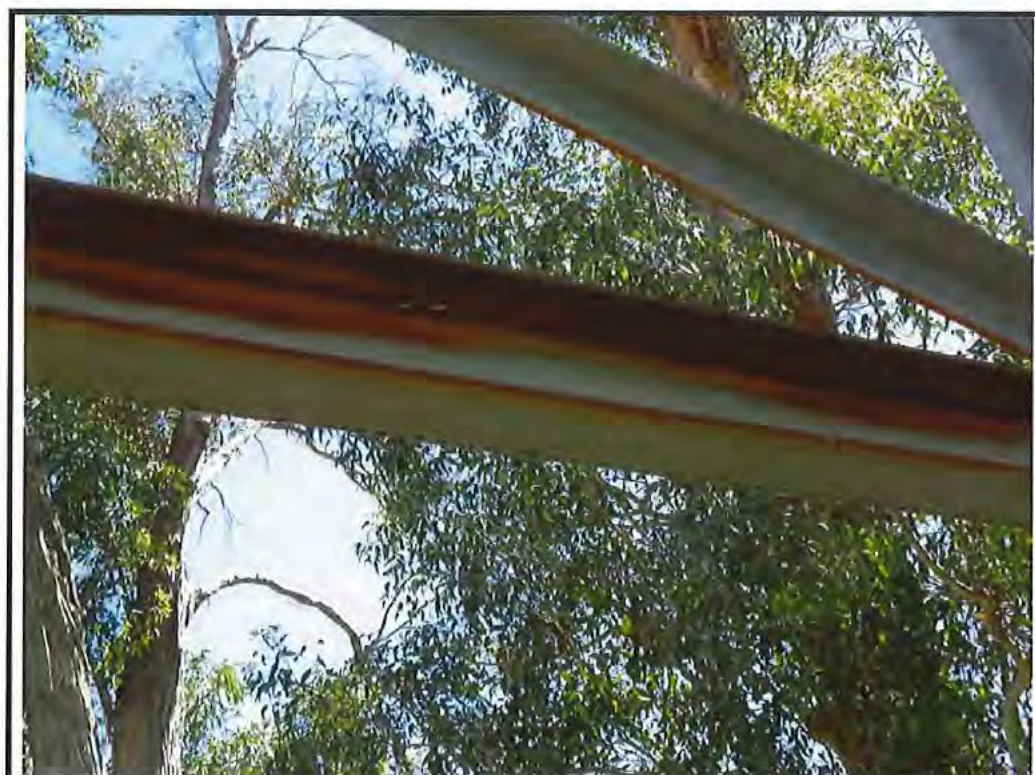
Photo No. 54: Surface corrosion to Pier 5 and 6 bracing

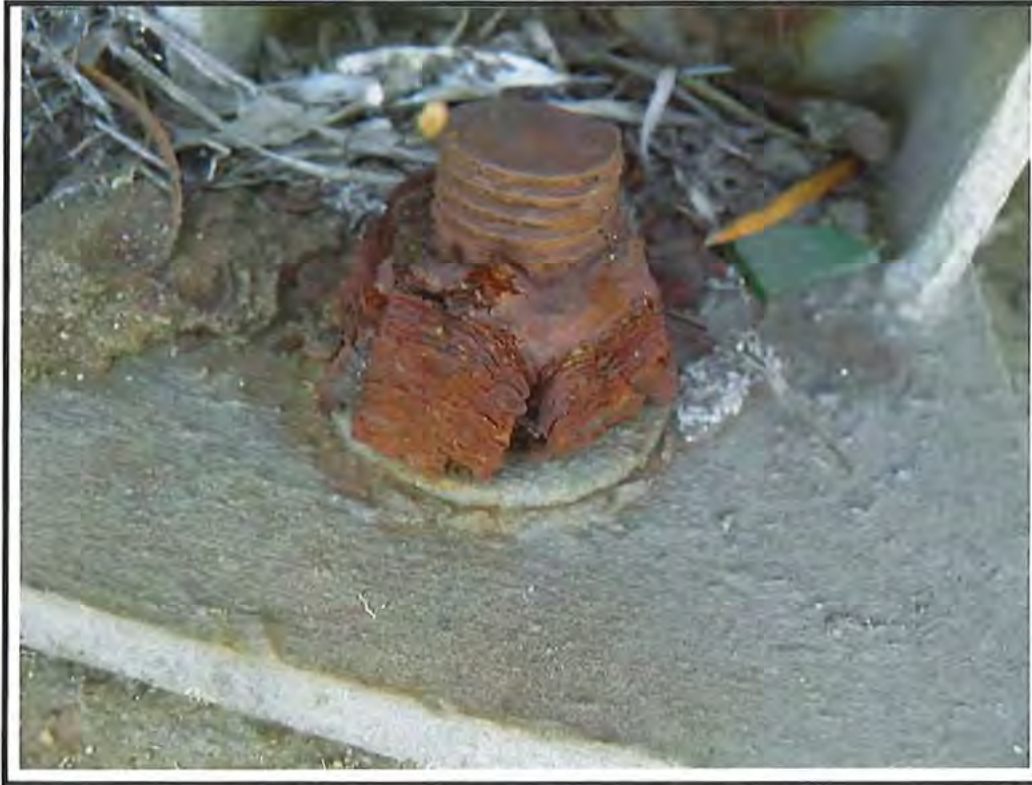
Photo No. 55: Corroded bolts to Pilaster 2

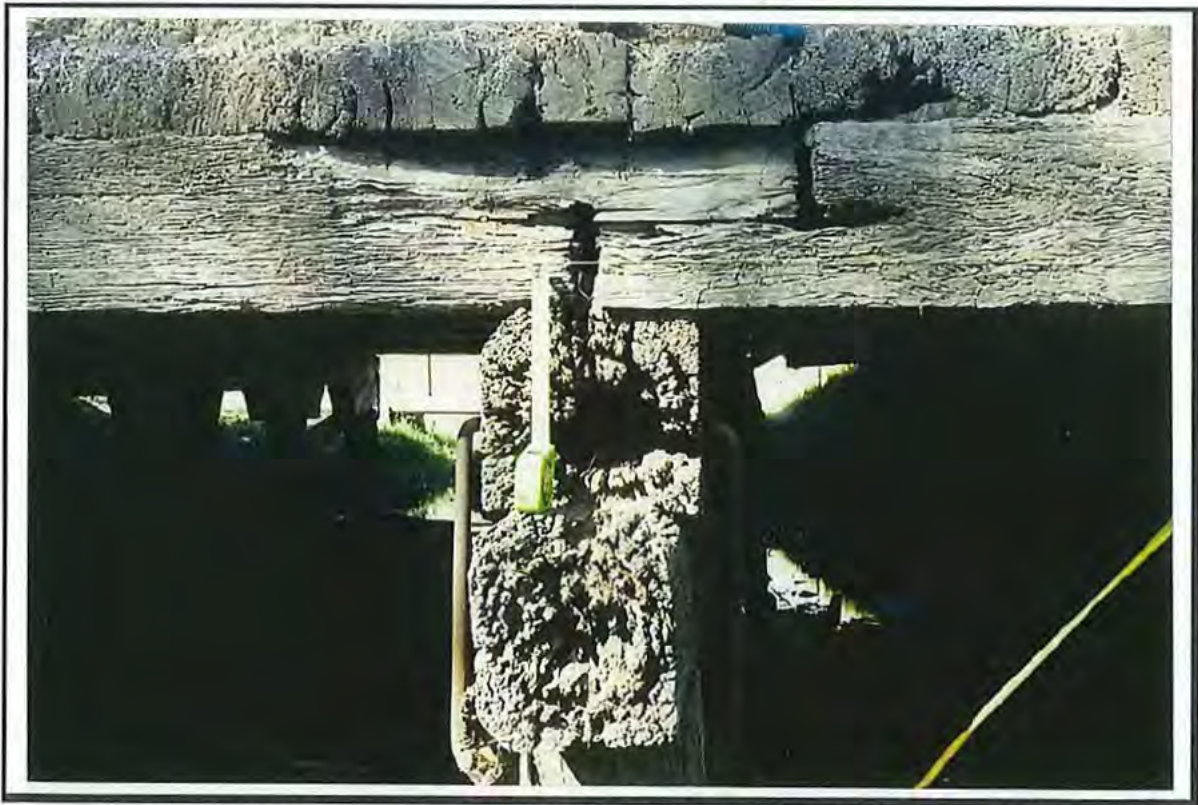
PIER 1 LEFT HAND SIDE SHOWING SUBSIDENCE 60-70MM FULL CAP  
CONDITION & CORBEL 1 LEFT HAND SIDE END CONDITION

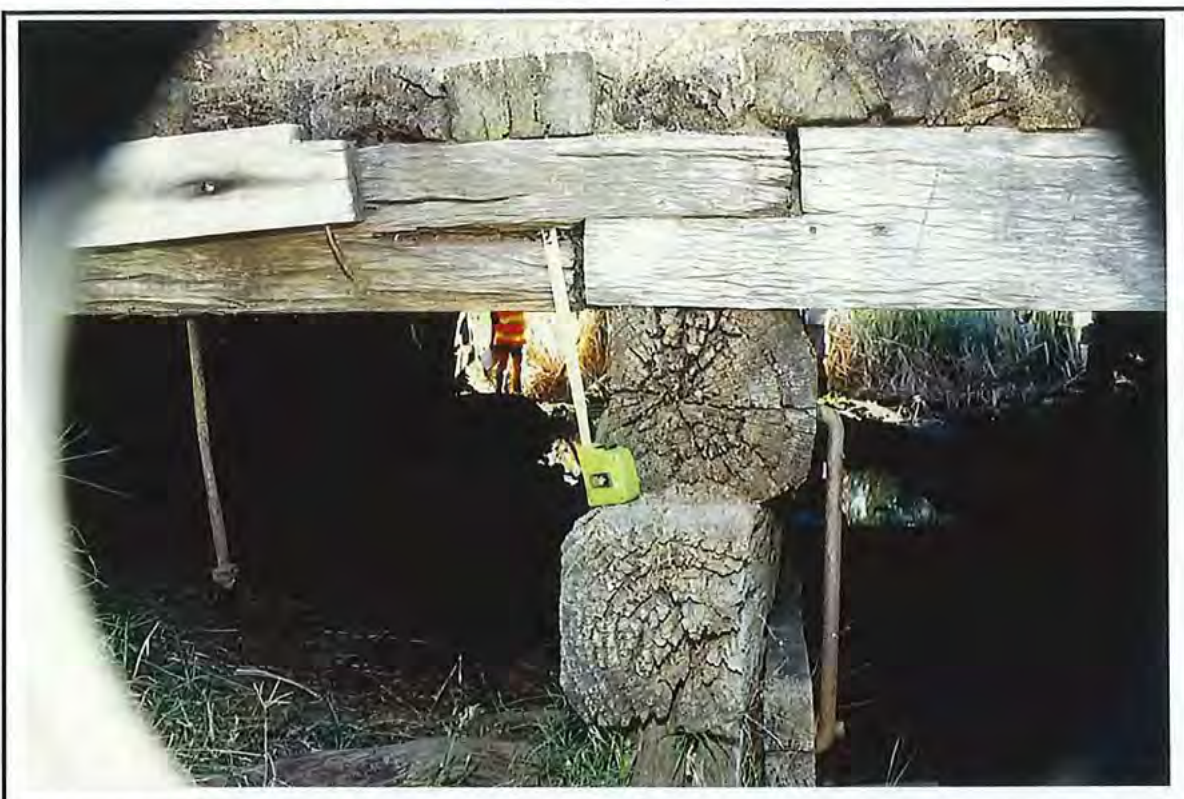
PIER 1 RIGHT HAND SIDE END CONDITION - NB STRINGER 11 END LARGE HORIZONTAL SPLIT AT CHECK OUT

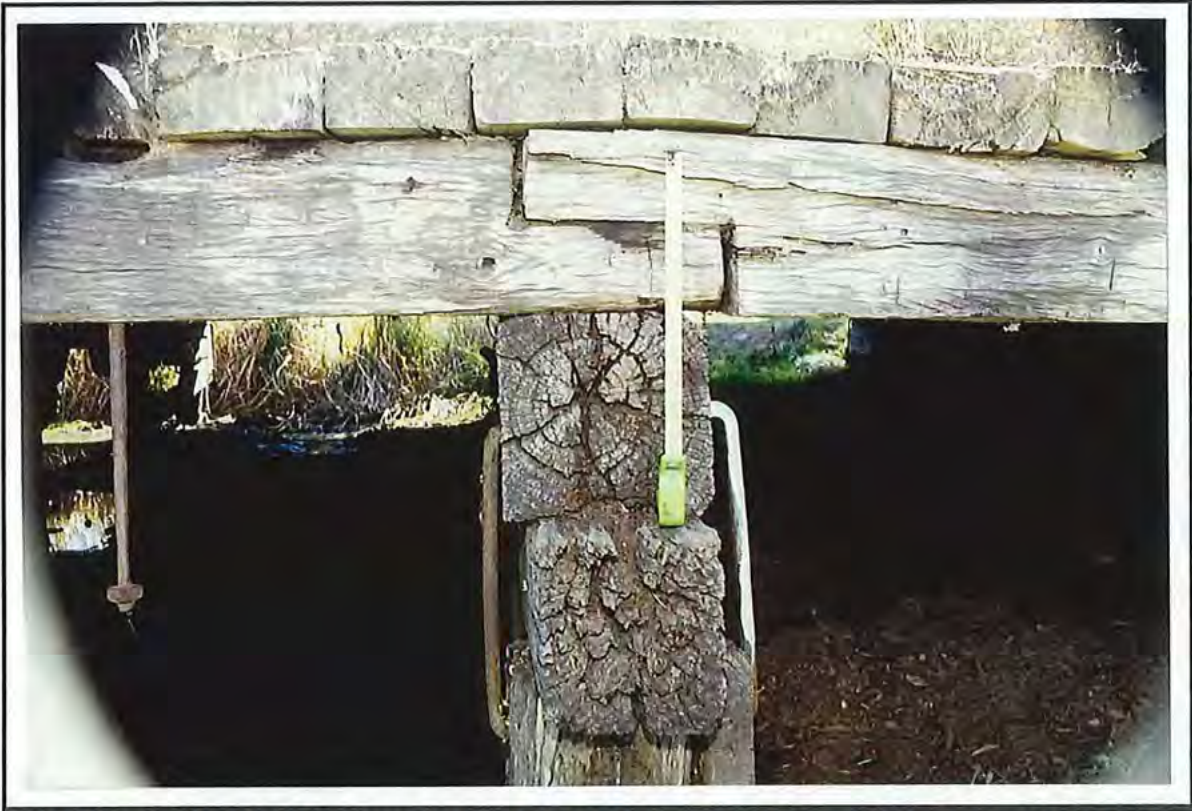
PIER 2 RIGHT HAND SIDE END CONDITION – NB OVER LAPPING STRINGERS

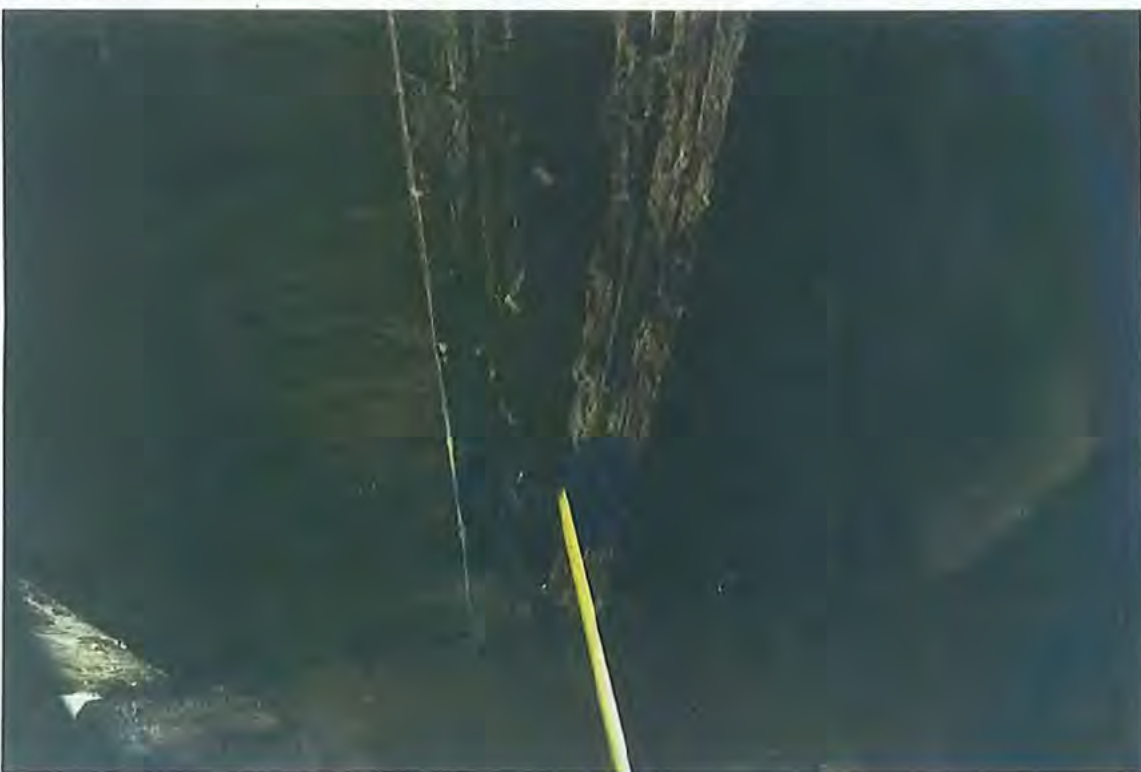
SPAN 3 STRINGER 10 SHOWING LARGE PIPE AT BOTTOM ALMOST FULL  
LENGTH OF STRINGER

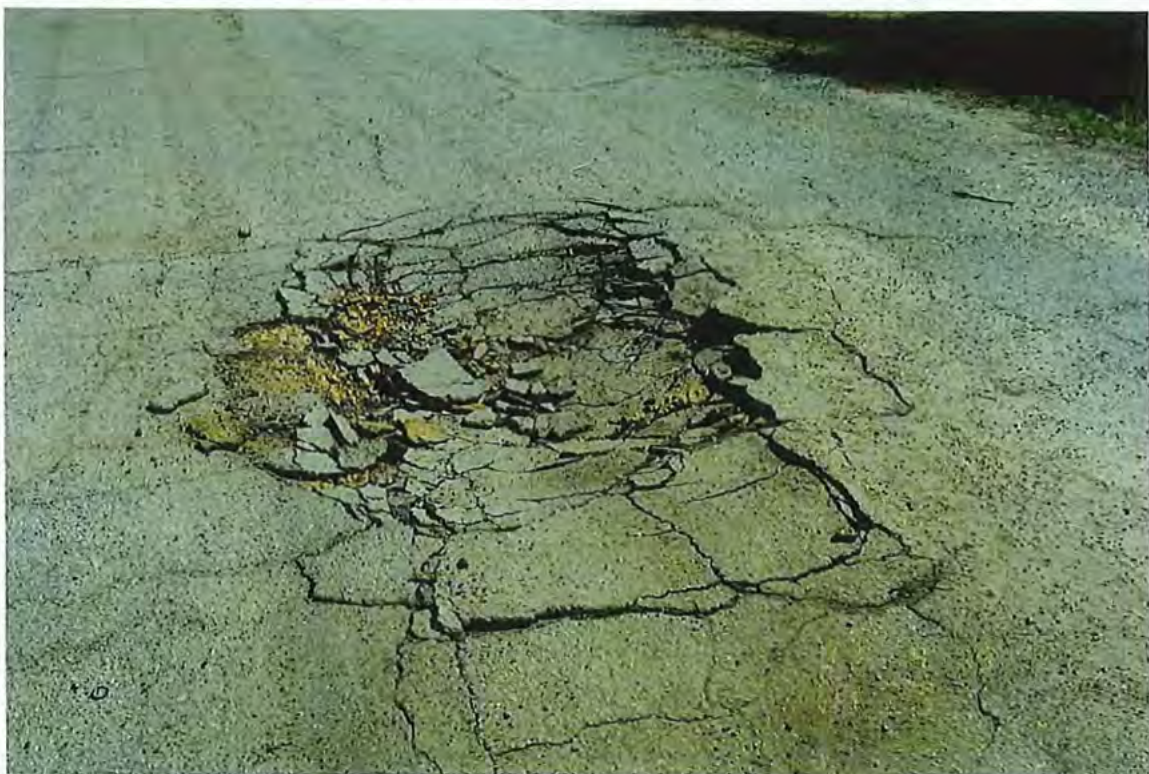
MAJOR FAILURE IN ROAD SURFACE OVER STRINGER 5 ABUTMENT 1 END Page 17

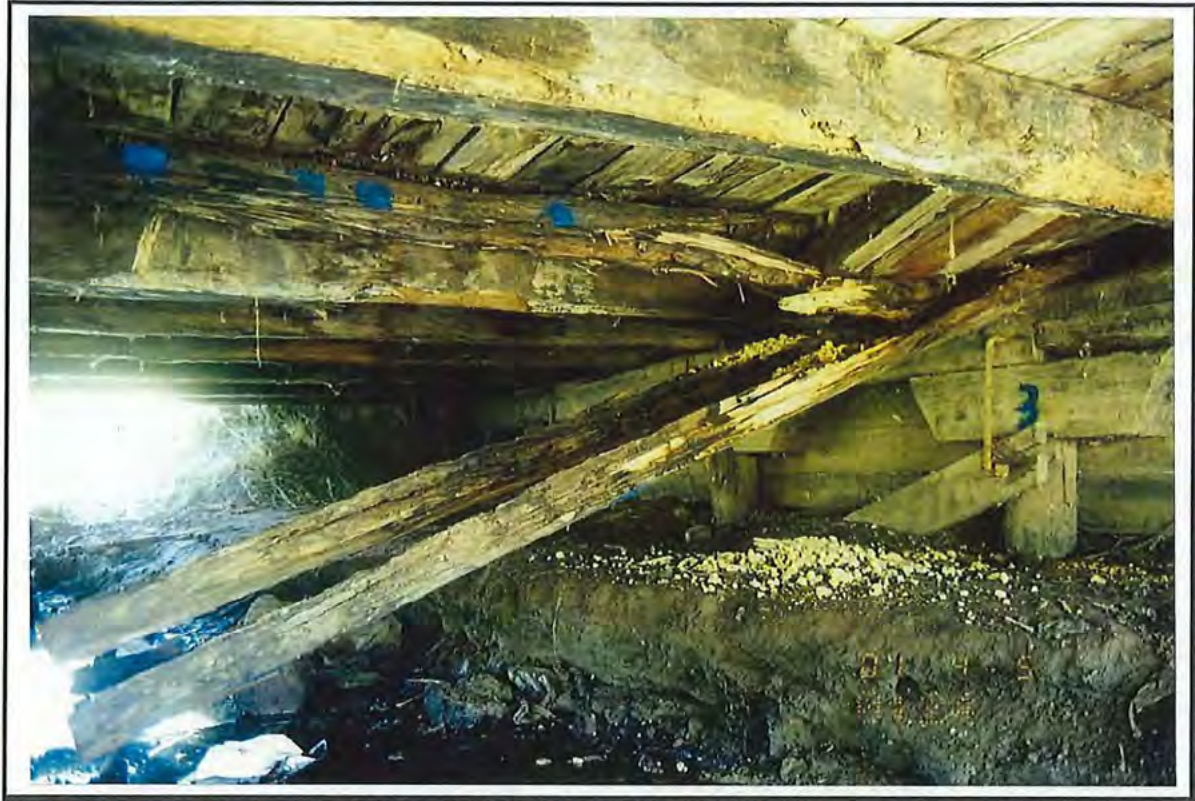
STRINGER 5 SPAN 1 SPLIT &amp; BROKEN

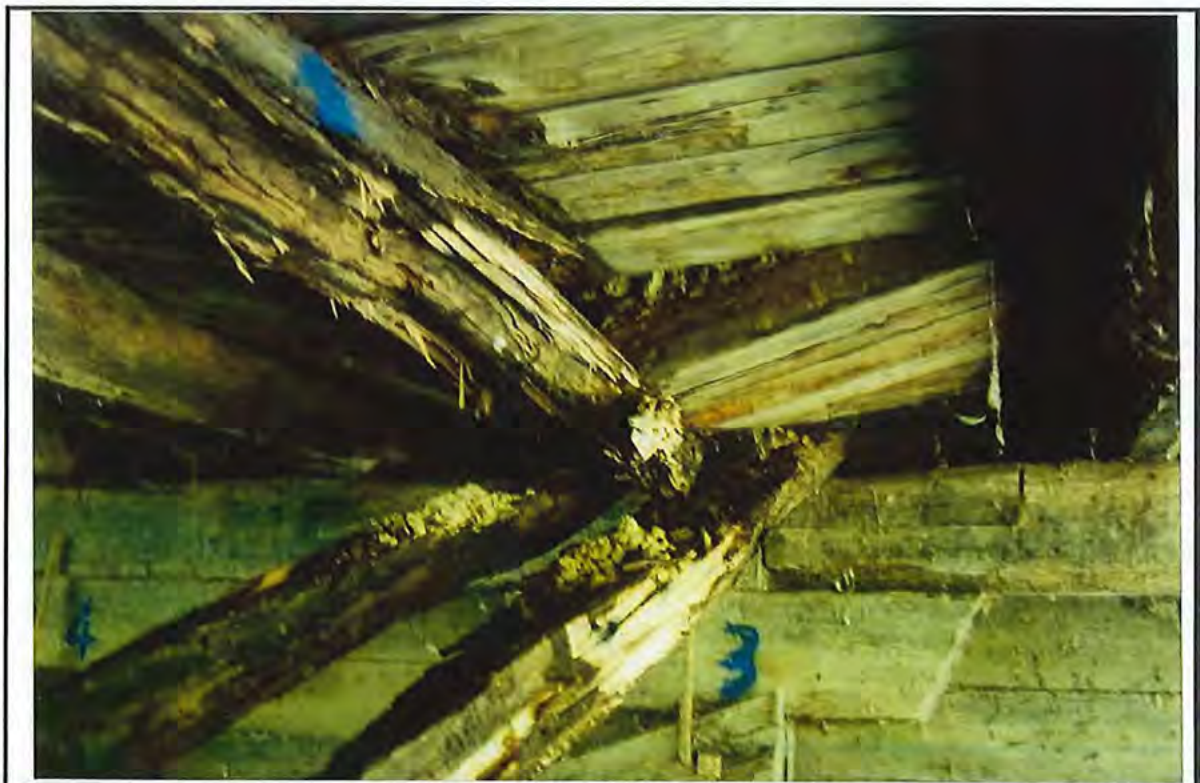
DECKING COLLAPSED AT STRINGER 5 ABUTMENT 1 END
