Shire of  
**Narrogin**  
*Love the life*

## BRIDGES ASSET MANAGEMENT PLAN

2020-2030

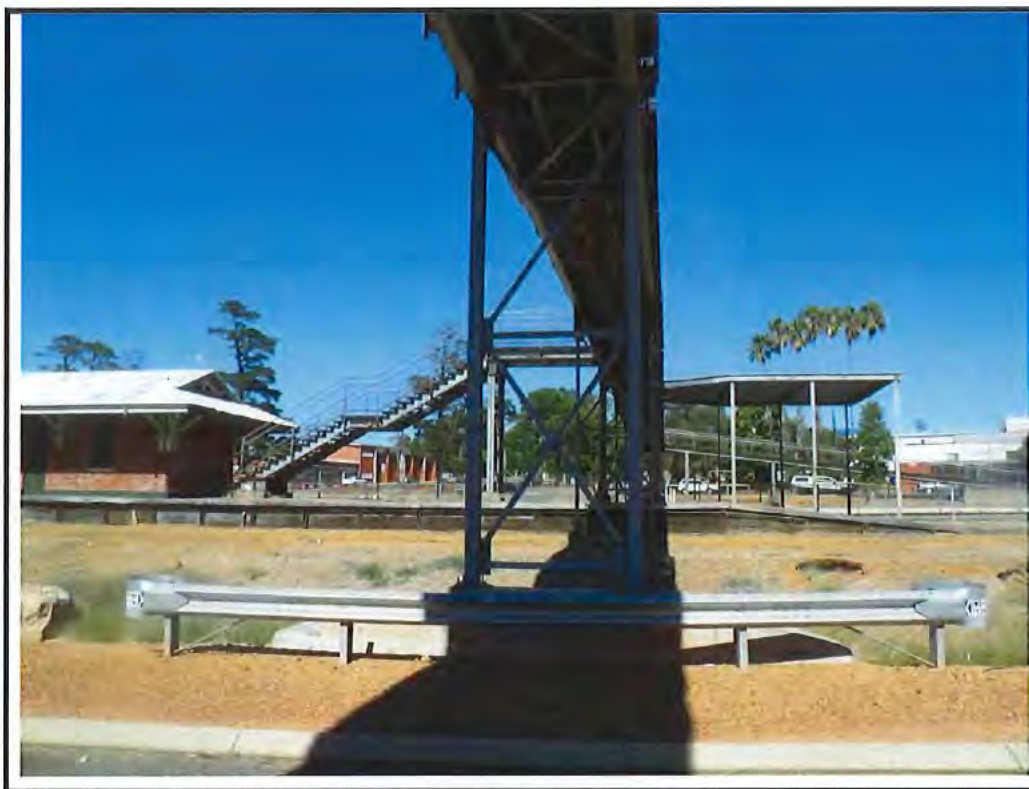
Photo No. 19: Pier 2

CORBEL 3 A1 REQ PACKING - SEE PHOTO 13  
H/C REQ TIGHTENING. A2 H/C HAS 25mm GAP BETWEEN PILE 1 + 3. A2 H/C HAS ROLLED OUT FROM PILE, 35mm GAP BETWEEN PILE + H/C AND 10mm ON BOTTOM OF H/C.  
CORBEL 2 A2 repacking Pile 2 A1 H/C req packing (Photo 19). Corbel 6 A2 halfmooring washer not making contact (Photo 18)  
not required

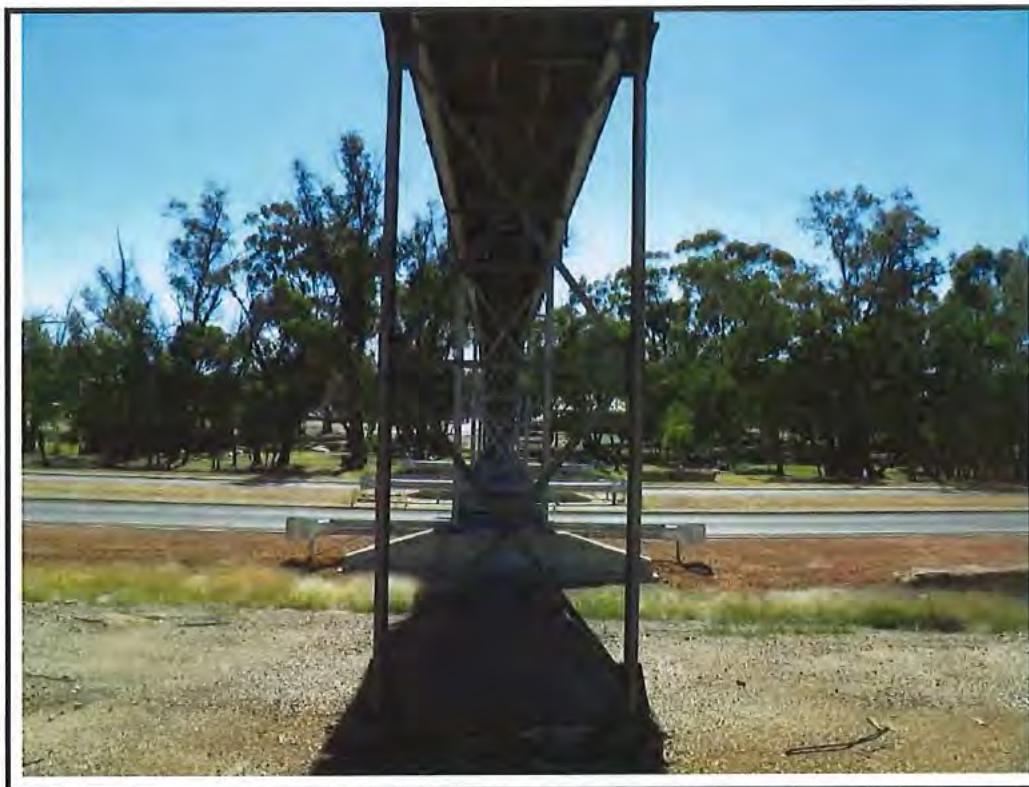
Photo No. 21: Pier 1

Corbel 3 A2 req packing (Photo 21) Pier 3 H/C packing req Pile 1 (Ph 24)

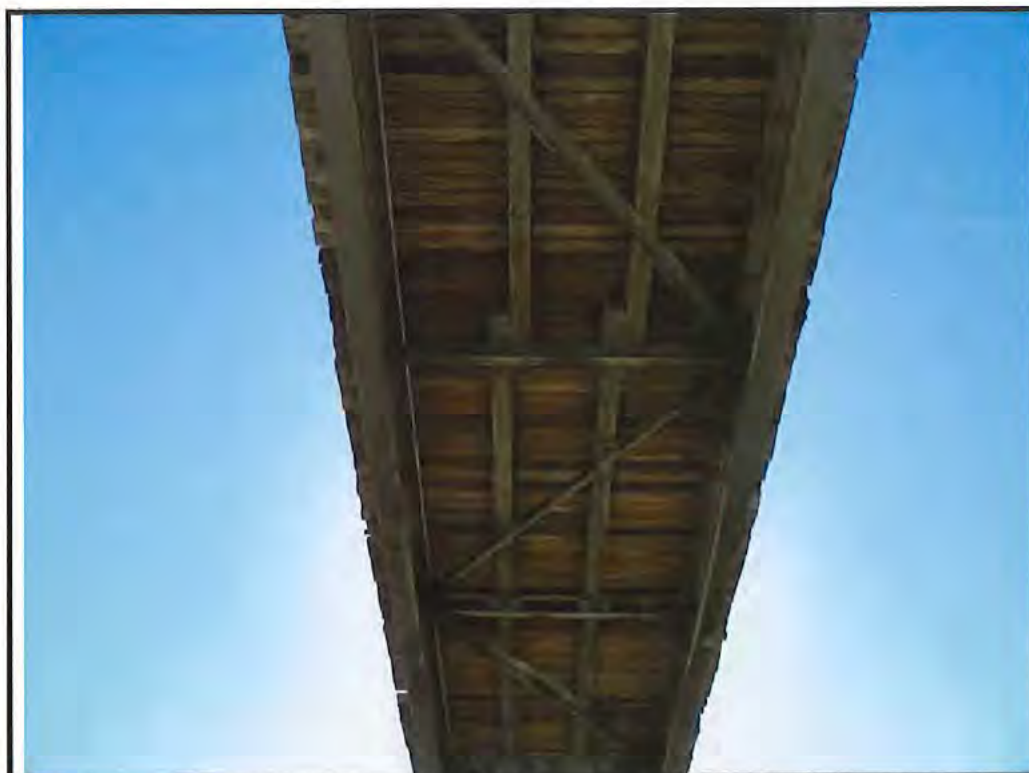
Photo No. 22: Span 1

Comments: Stringer 2 Abut 2 req packing (Photo 22) } NOT REQUIRED

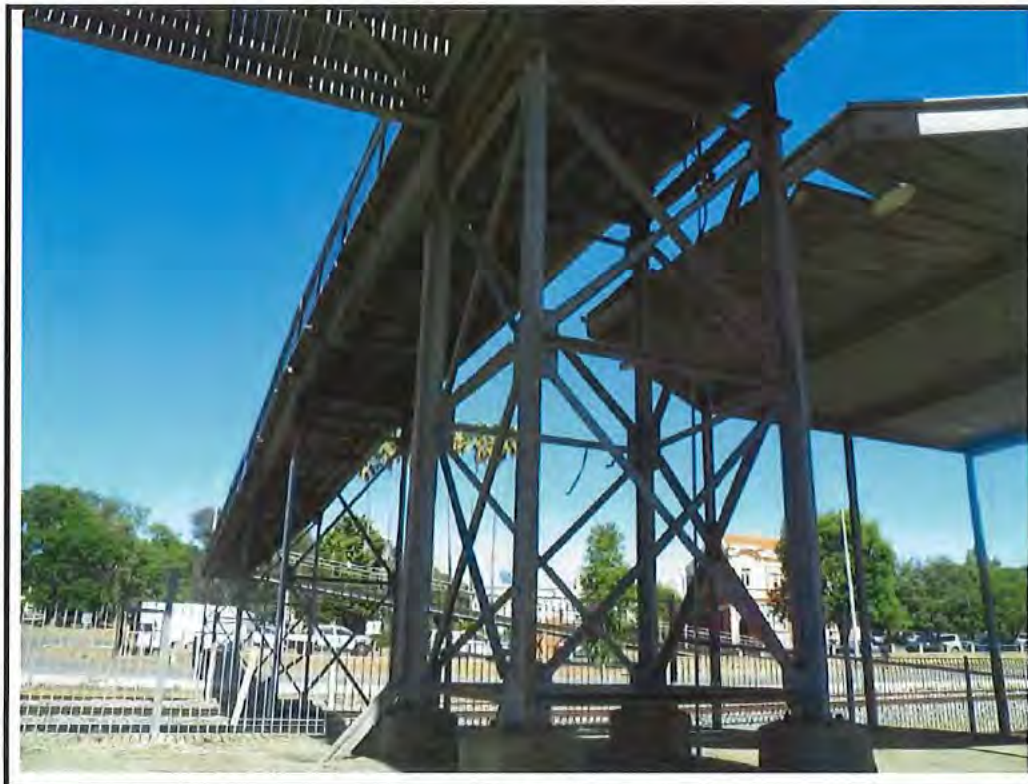
Photo No. 25: Pilaster 1

Unable to drill pile 4 at ground level large amount of debris  
Pier 2 Corbel 7 A1 req. packing (Photo 25).

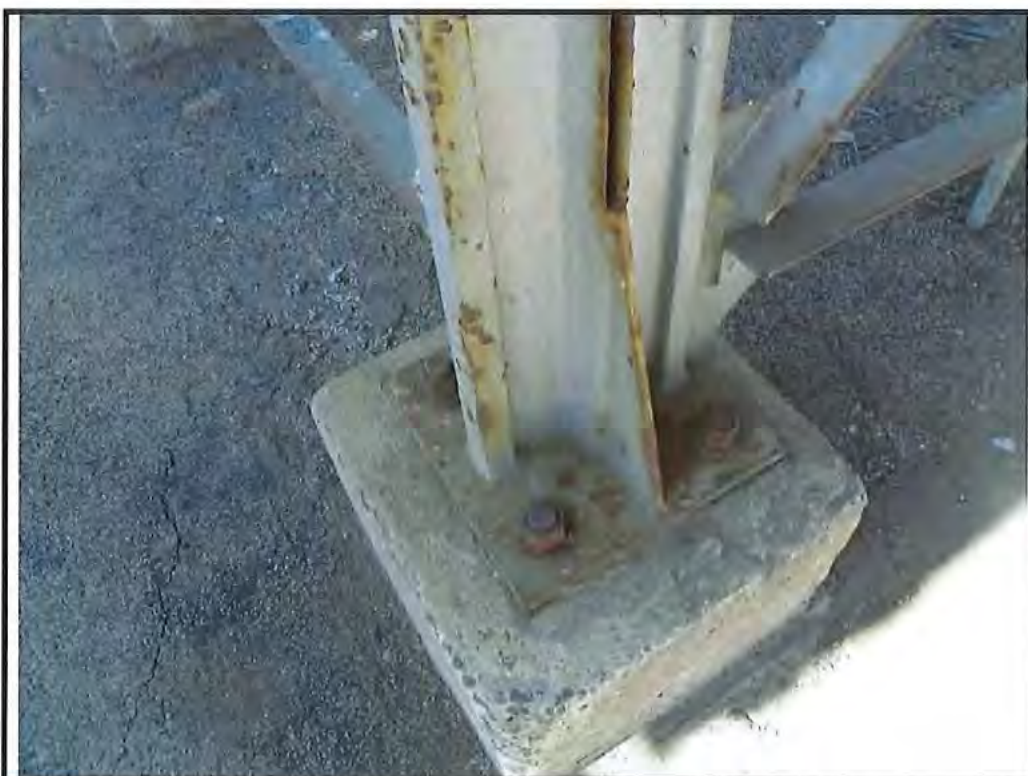
Stringer 7 A2 req packing (Photo 26)

Photo No. 26: Rusting to all Pilaster 1 bolts – minor surfacing rust to steel

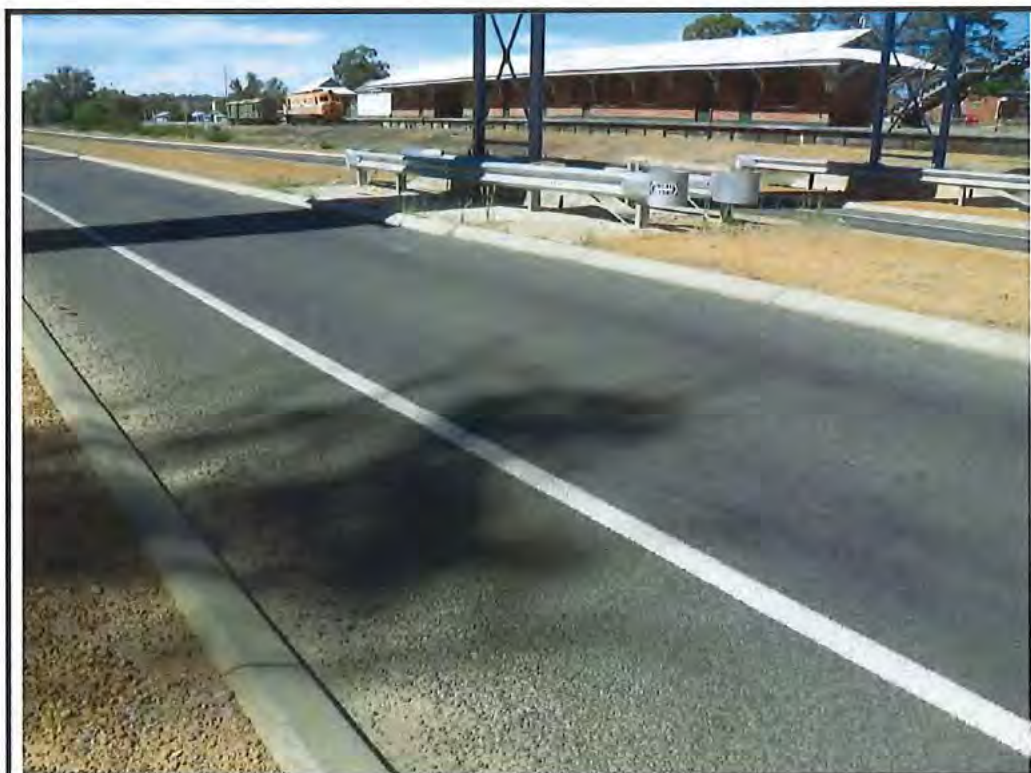
Photo No. 34: Carriageway surfacing

Kerbing: Concrete, OK	
	APPROACHES	Road Surface: Bitumen seal minor cracking and depressions A1 + A2, Small hole A1 RHS see photo 34	
		Kerbing: Concrete - OK	
VEGETATION (R205)		Requires Clearing : LHS <input checked="" type="checkbox"/> Abut 1 <input checked="" type="checkbox"/> RHS <input checked="" type="checkbox"/> Abut 2 <input checked="" type="checkbox"/> Trees, scrub REMOVE	
STREAM BED CONDITION (General comments and details of location, depth & extent of scour, undermining and silt build up.) (R203)		Debris buildup pier 2+3 RHS	
SERVICES (Type, Size & Location)		Type	Size (mm)
		Location	
		None	
BRIDGE CONDITION		Priority for Engineering Assessment	
		Low <input checked="" type="checkbox"/>	Medium <input type="checkbox"/> High <input type="checkbox"/> Urgent <input type="checkbox"/>

Stringer 4 About 2 req packing (Photo 34)

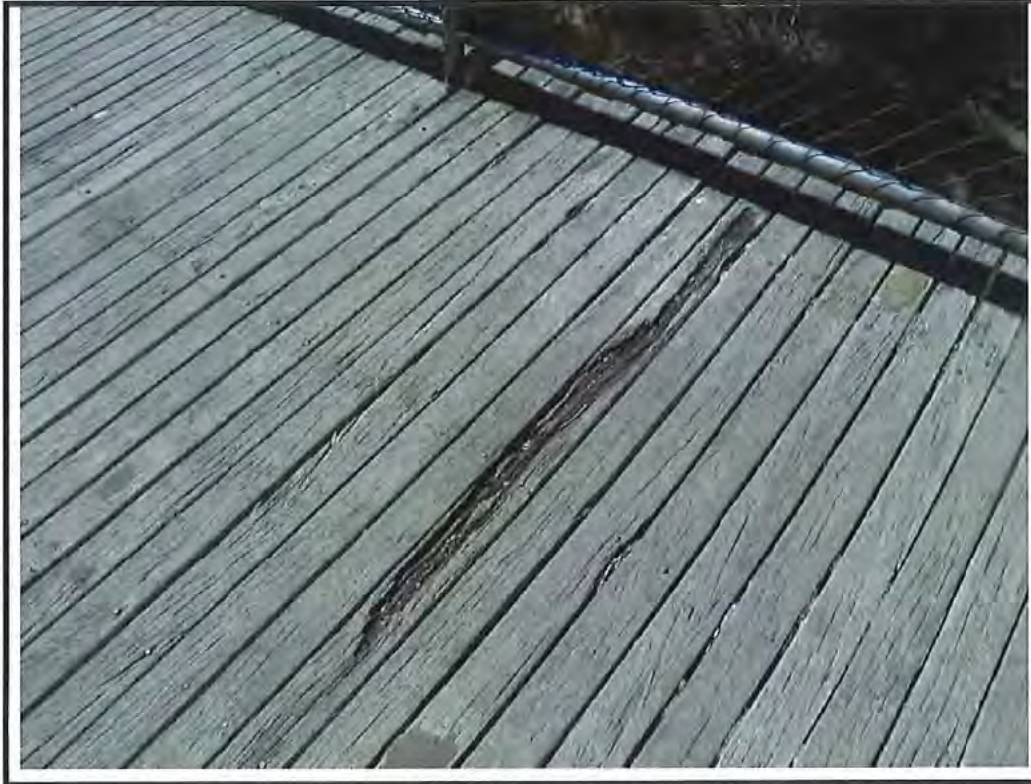
Photo No. 49: Rotten timber to deck – Span 2

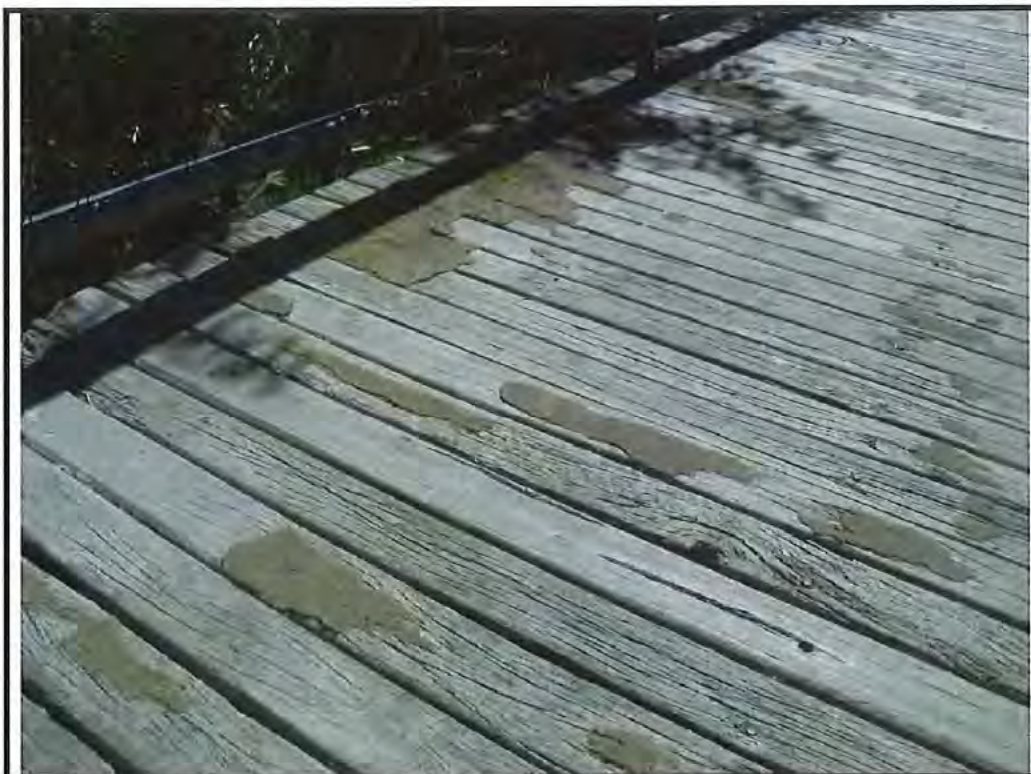
Photo No. 50: Anti-slip surfacing come of the ramp section of deck

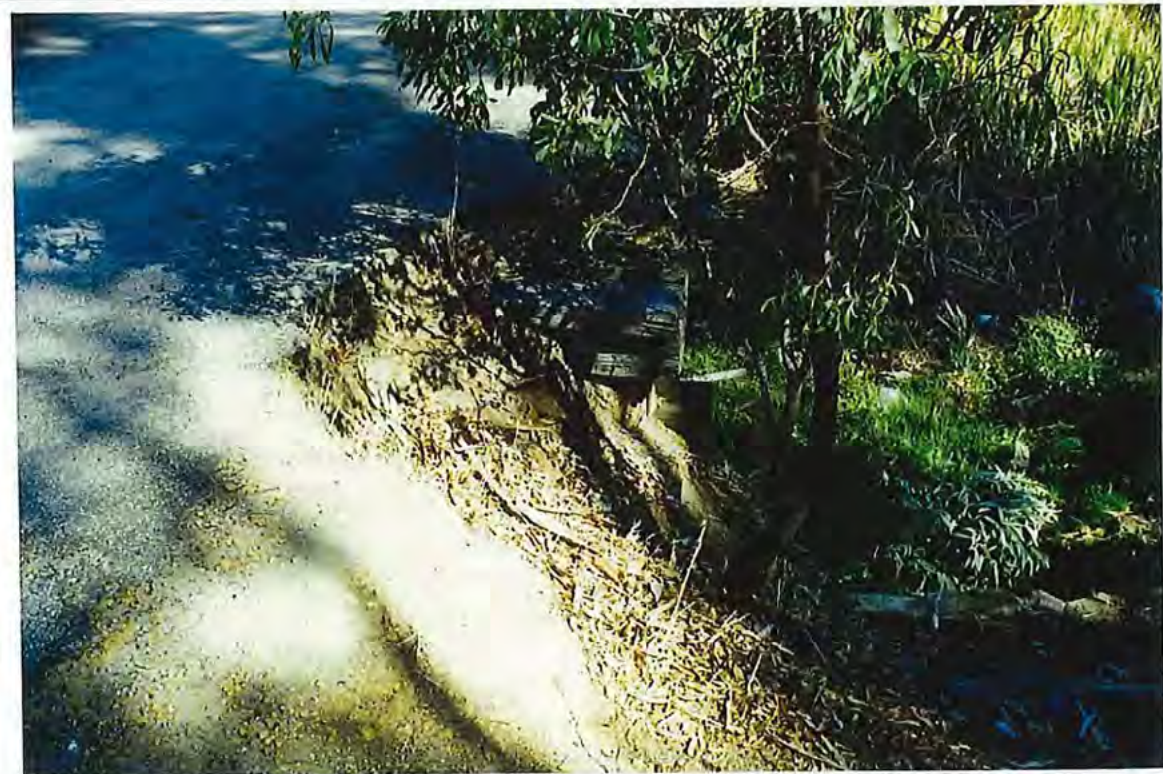
MAJOR SCOUR AT ABUTMENT 2 LEFT HAND SIDE APPROACH-FROM  
ABUTMENT 2 END

| H | The approaches at the ends of the bridge require repairs. | <input type="checkbox"/> N |

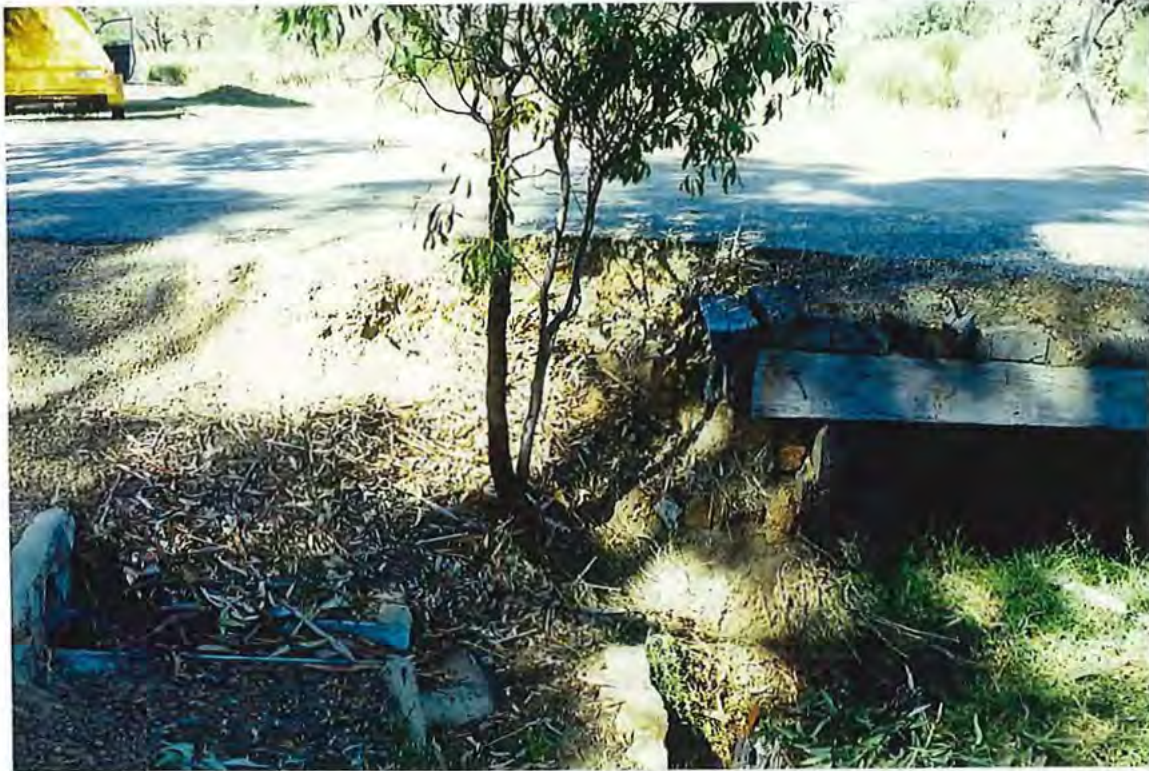
MAJOR SCOUR AT ABUTMENT 2 LEFT HAND SIDE APPROACH – FROM LEFT HAND SIDE

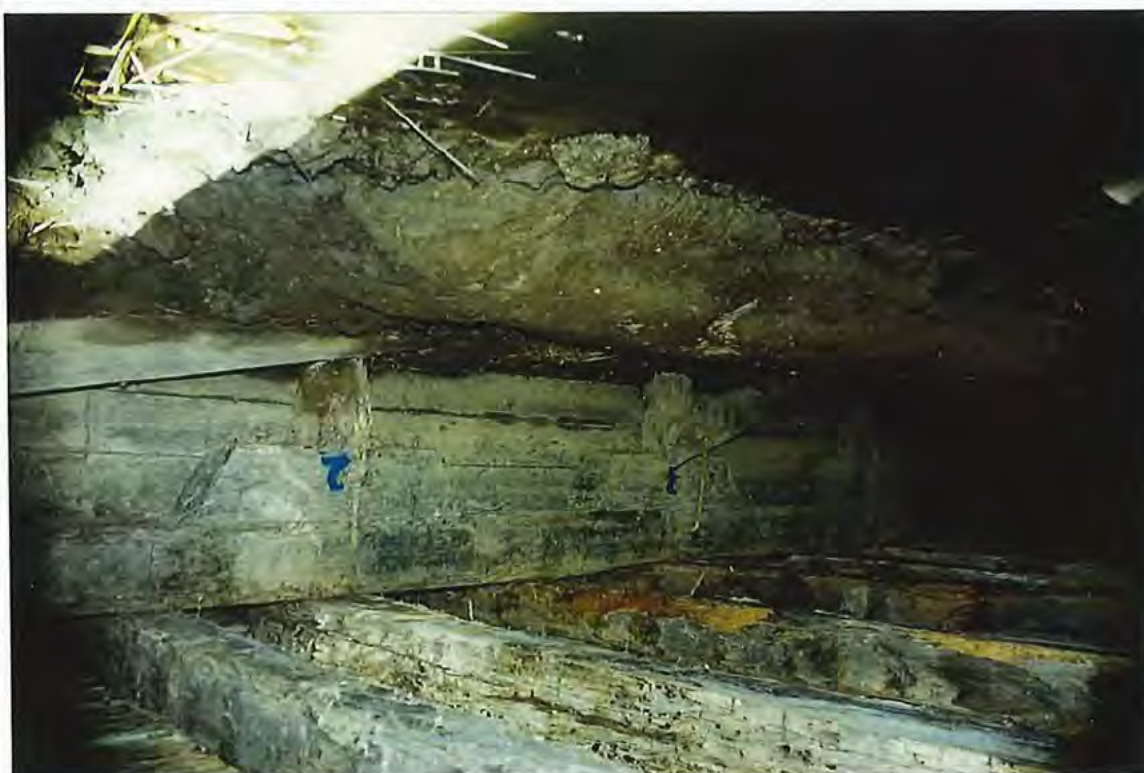
ABUTMENT 1 LAYOUT LEFT HAND SIDE

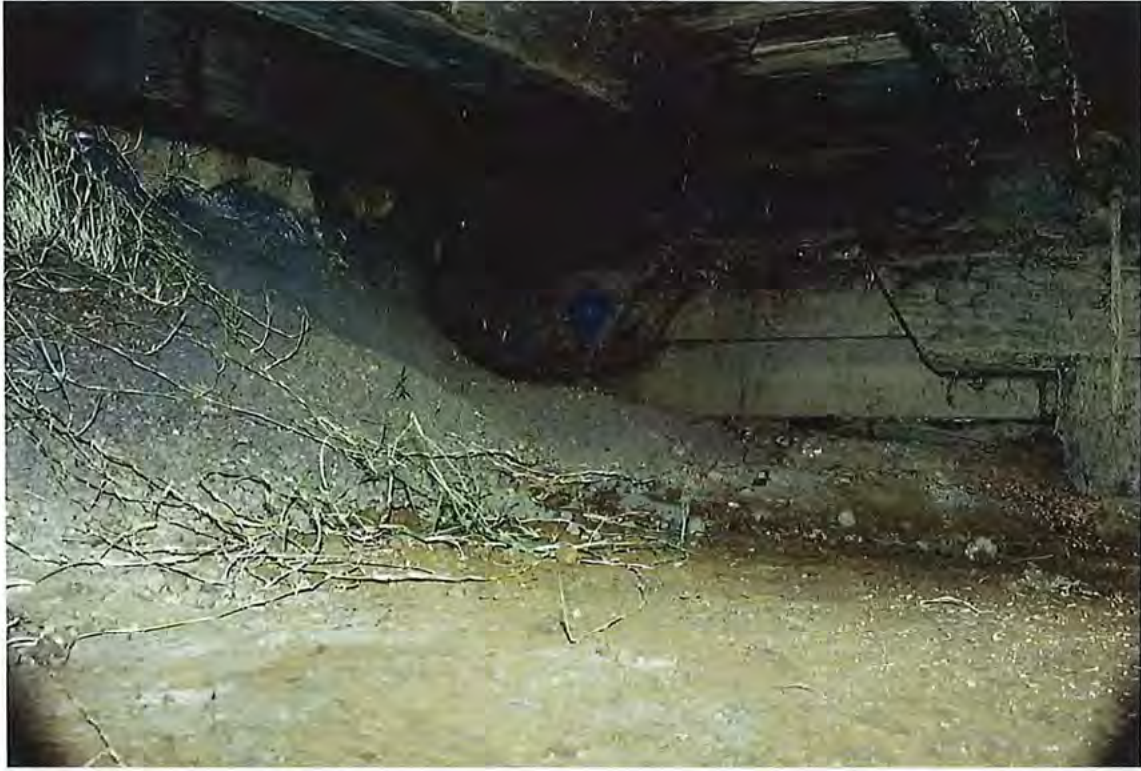
ABUTMENT 1 LAYOUT RIGHT HAND SIDE

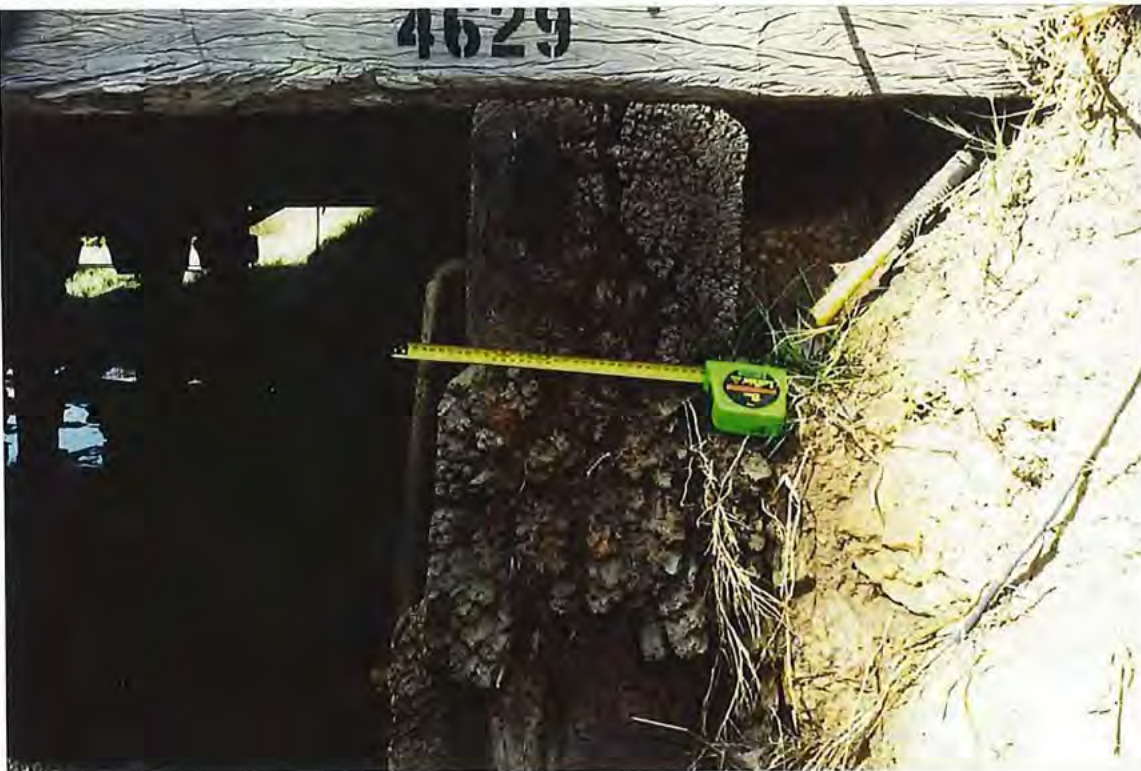
ABUTMENT 1 CORBEL 1 LEFT HAND SIDE END CONDITION - NB FULL CAP

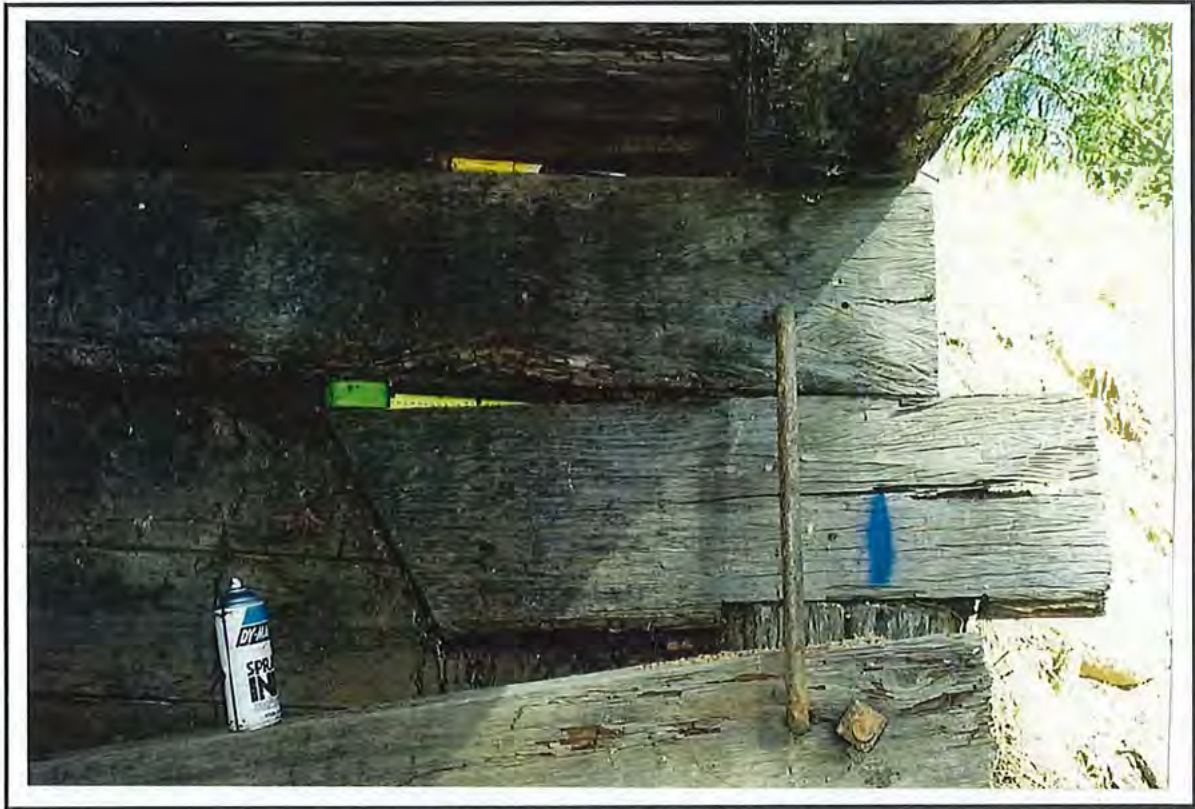
ABUTMENT 1 CORBEL 1 TILTED

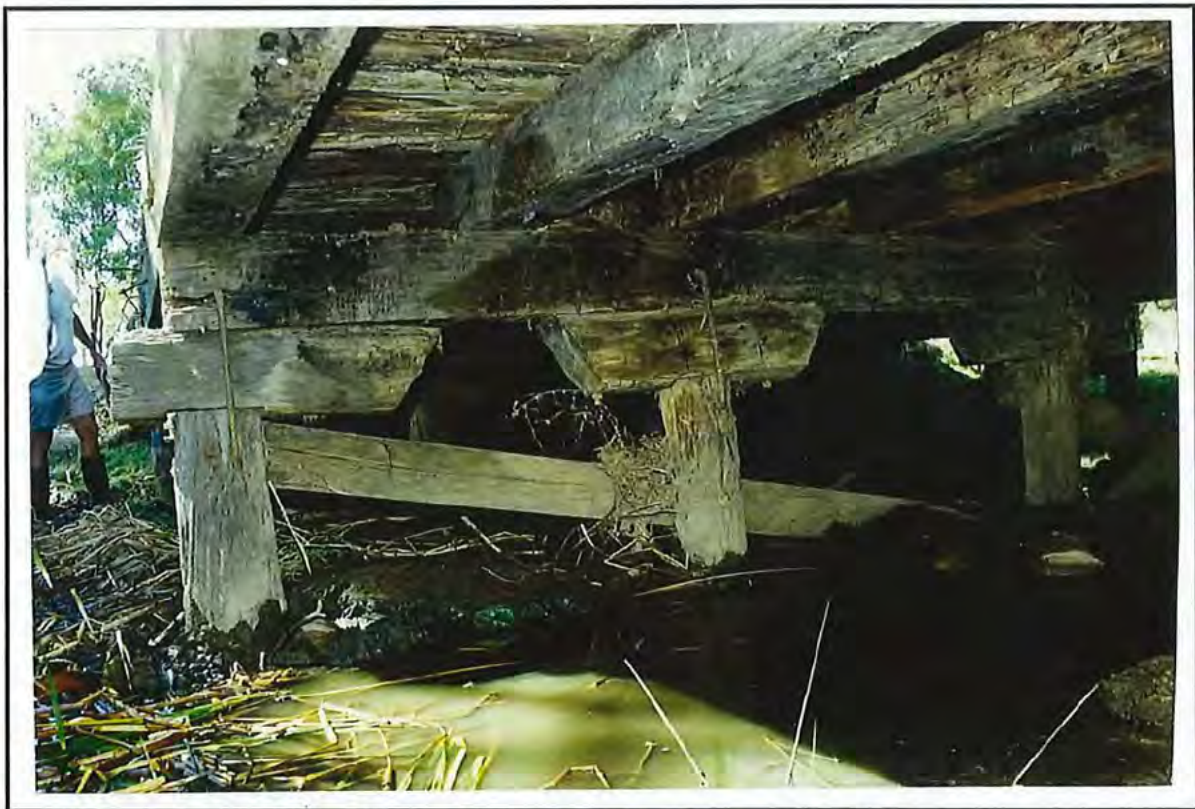
PIER 1 LAYOUT AT LEFT HAND SIDE FROM ABUTMENT 1

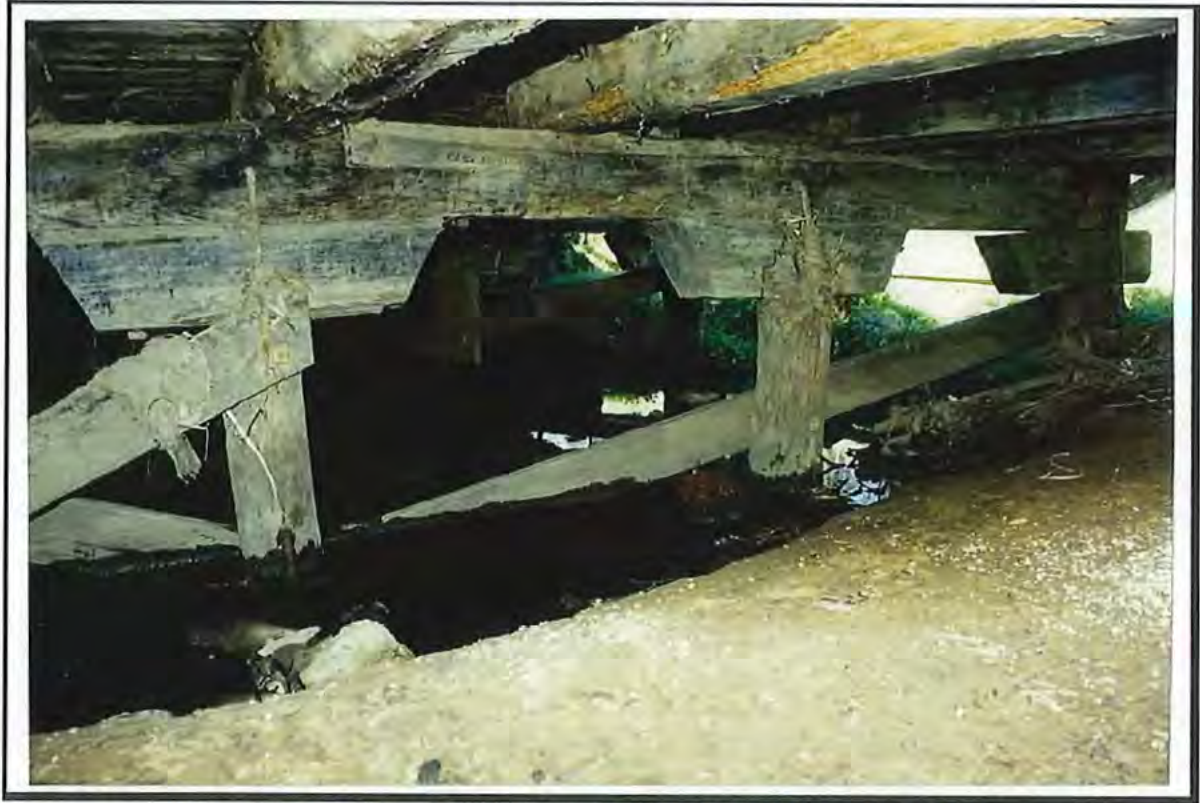
PIER 1 LAYOUT AT RIGHT HAND SIDE FROM ABUTMENT 1

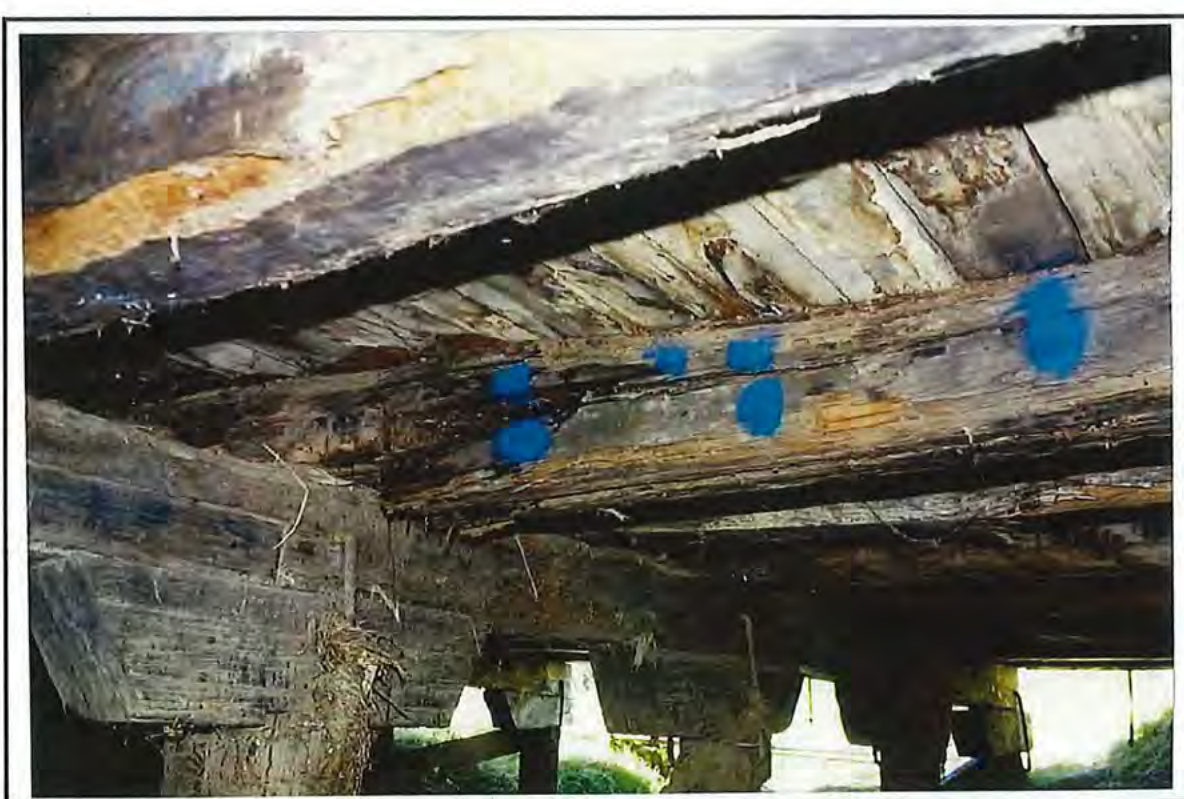
SPAN 1 STRINGER 5 ABUTMENT 2 END CONDITION FROM ABUTMENT 1 LHS Page 8

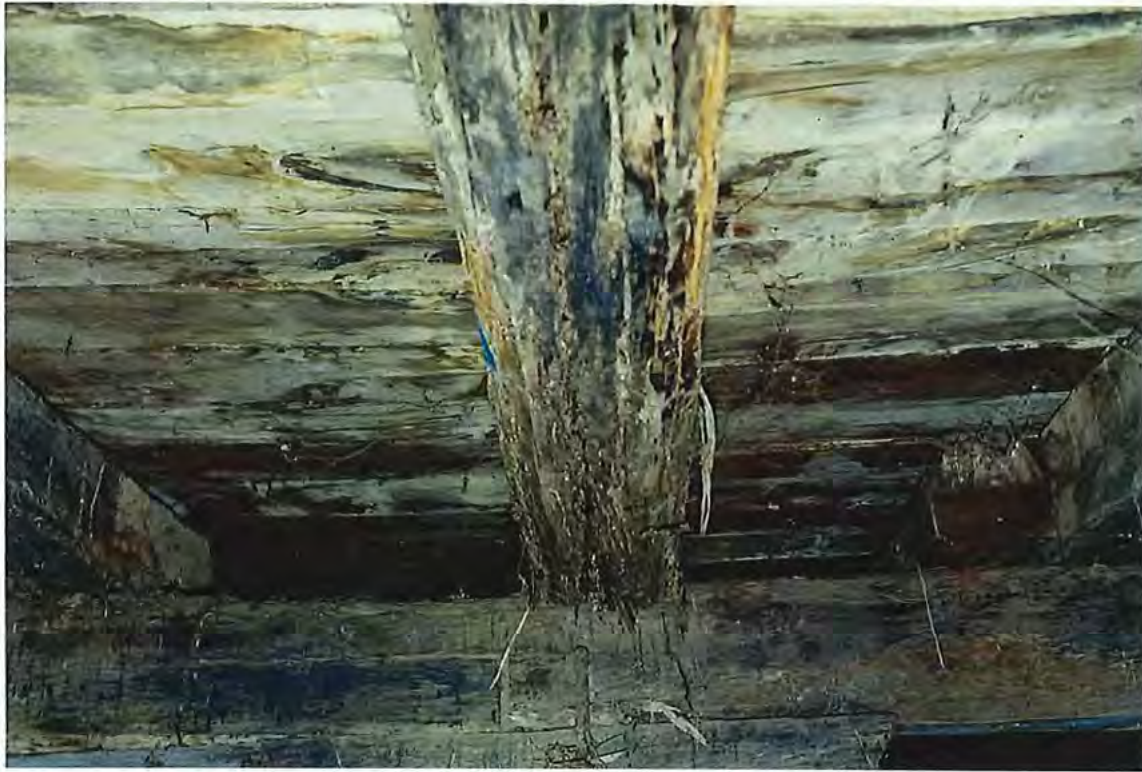
SPAN 1 STRINGER 5 ABUTMENT 2 END VIEW FROM BOTTOM

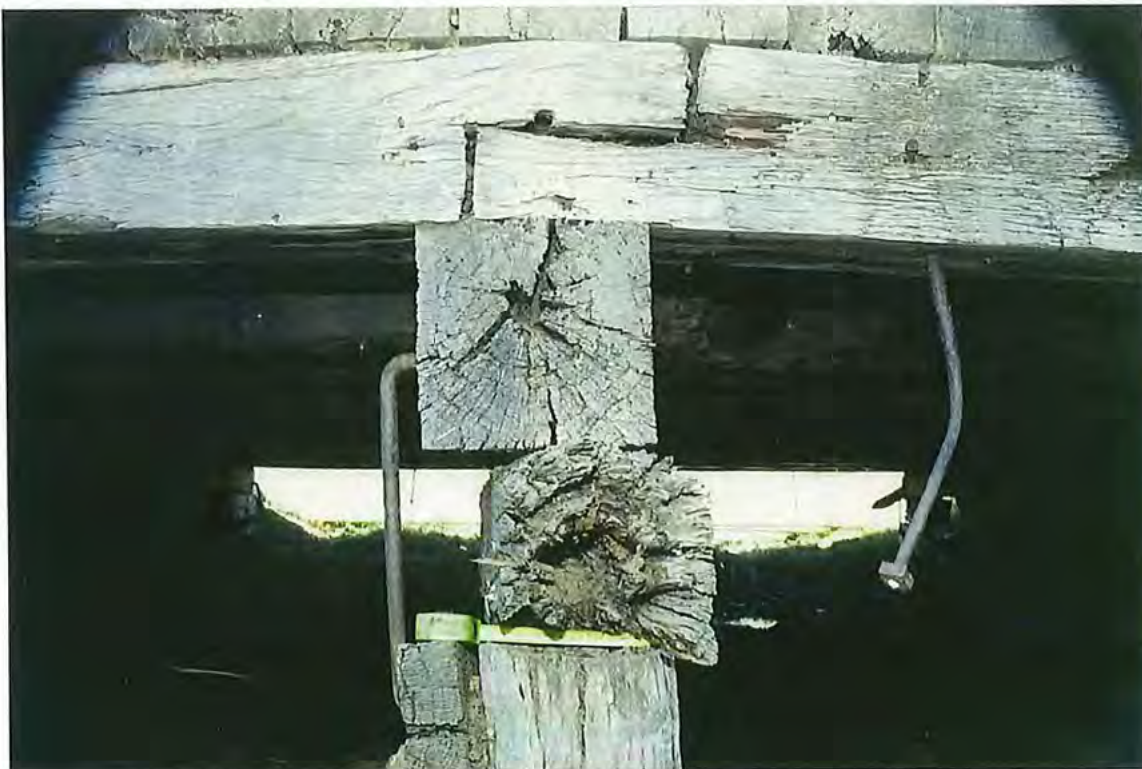
PIER 2 LEFT HAND SIDE END CONDITION-NB CORBEL 1 CONDITION

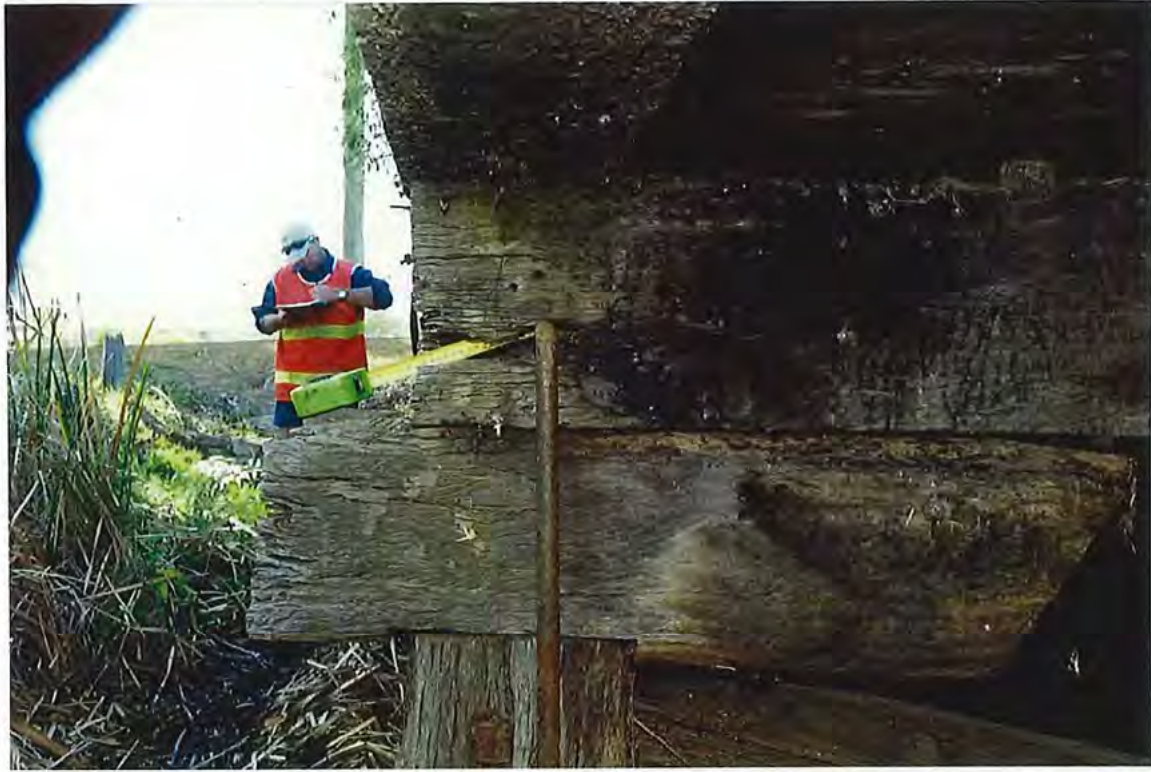
PIER 1 LEFT HAND SIDE END ABUTMENT 1 SIDE CONDITION

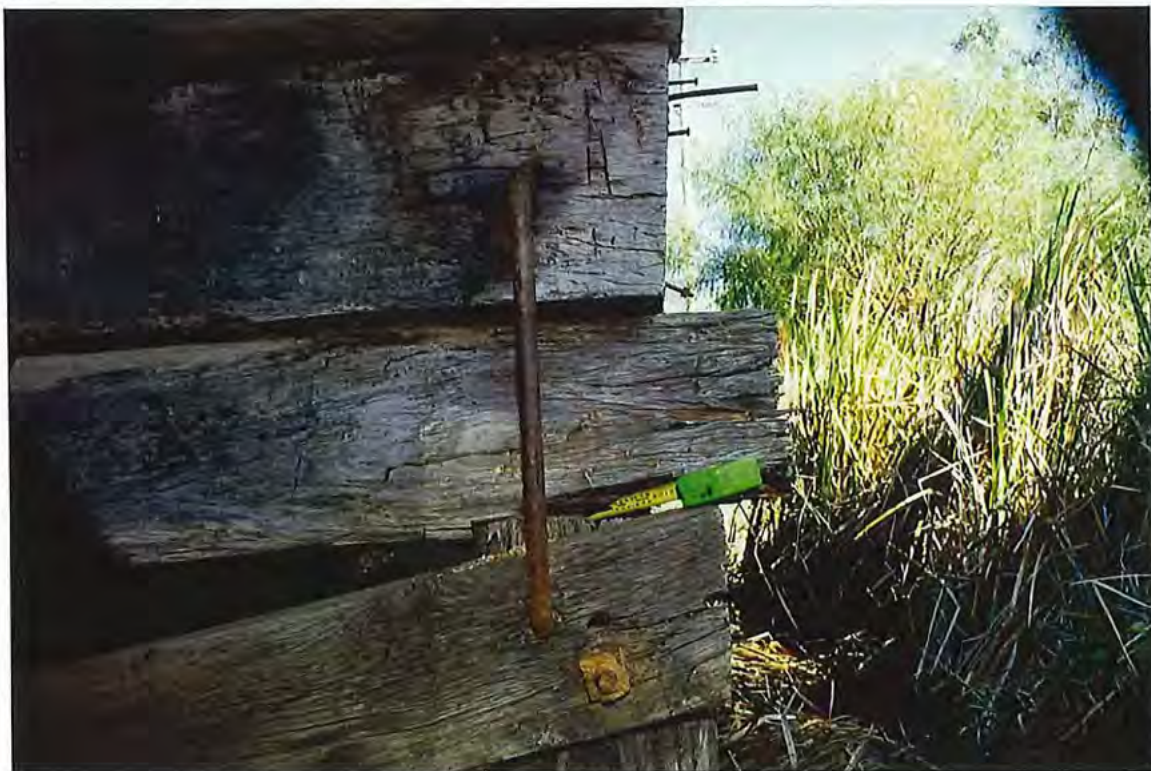
PIER 2 LEFT HAND SIDE END ABUTMENT 2 SIDE CONDITION OF CORBEL

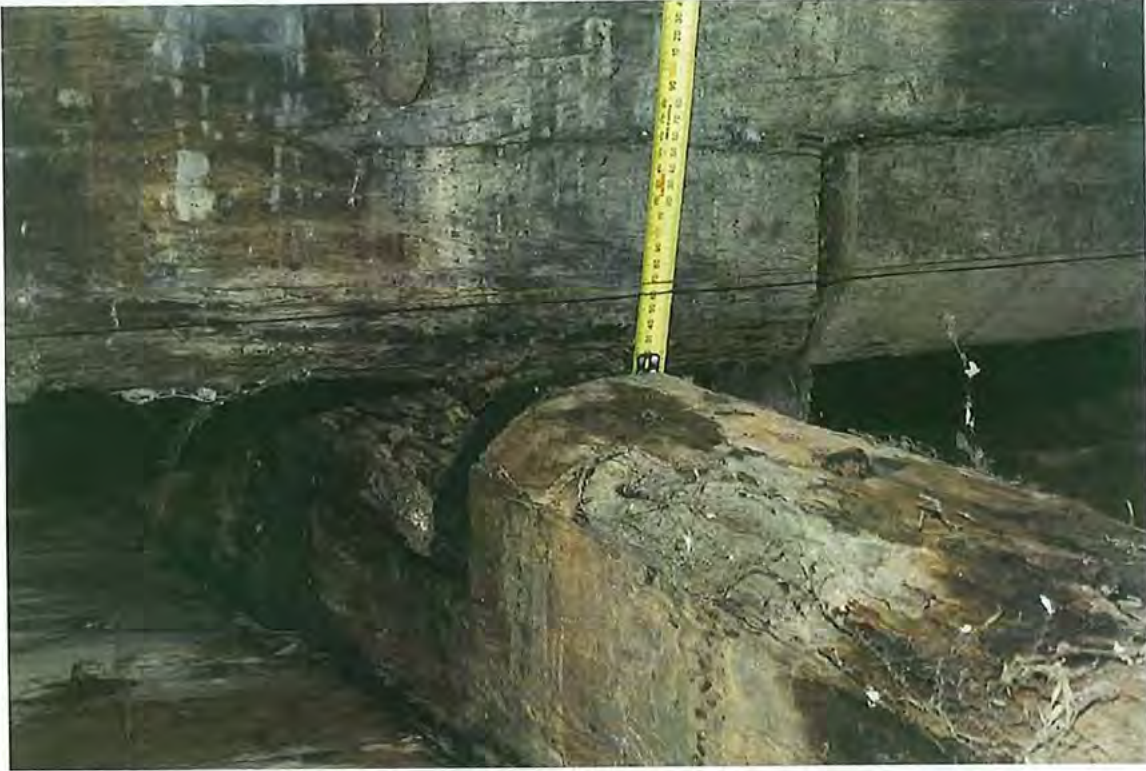
PIER 1 PILE 4 AT CORRECT HEIGHT

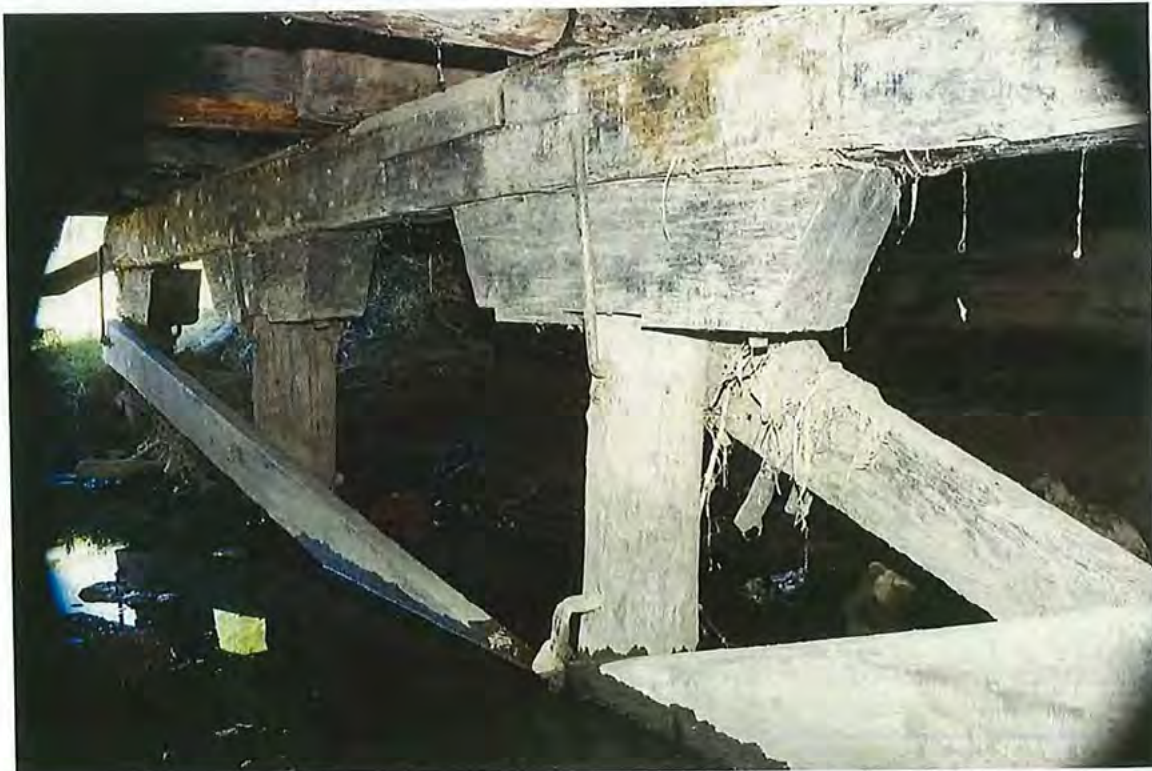
PIER 1 AT PILE 4 TIEING BARS – TYPICAL

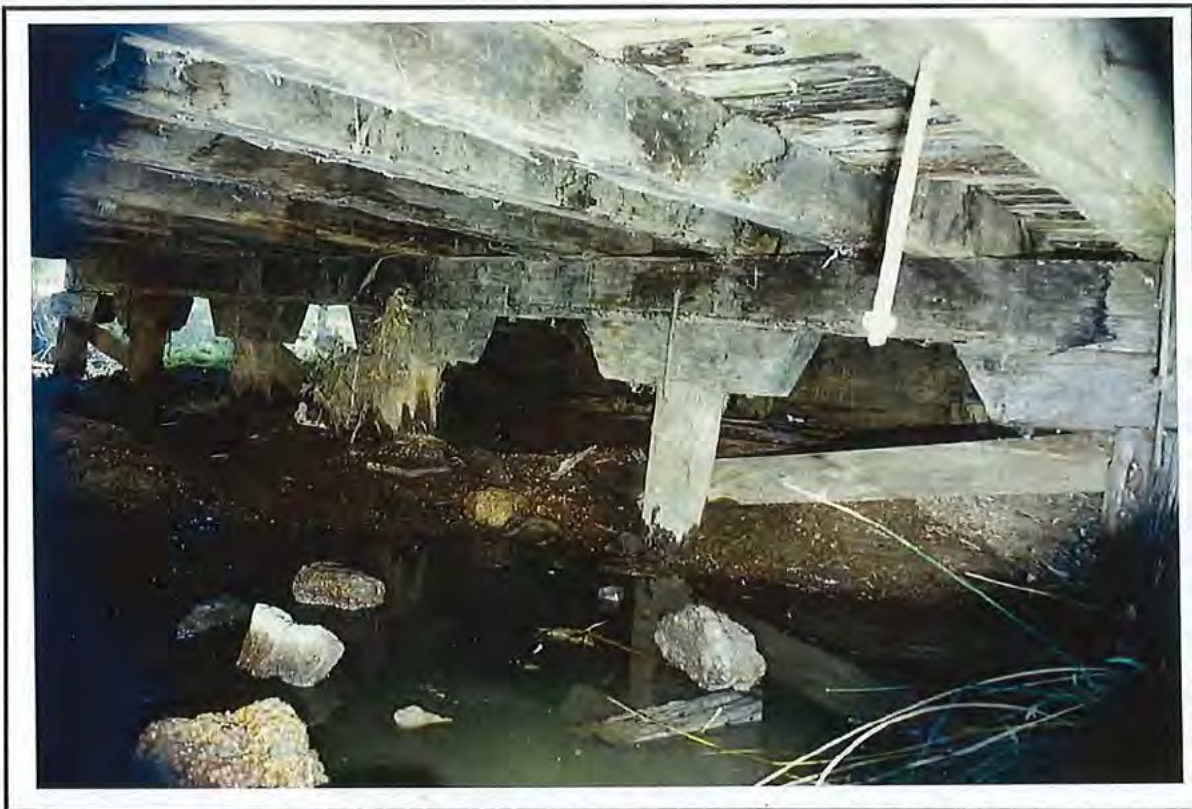
PIER 2 LAYOUT FROM ABUTMENT 1 RIGHT HAND SIDE

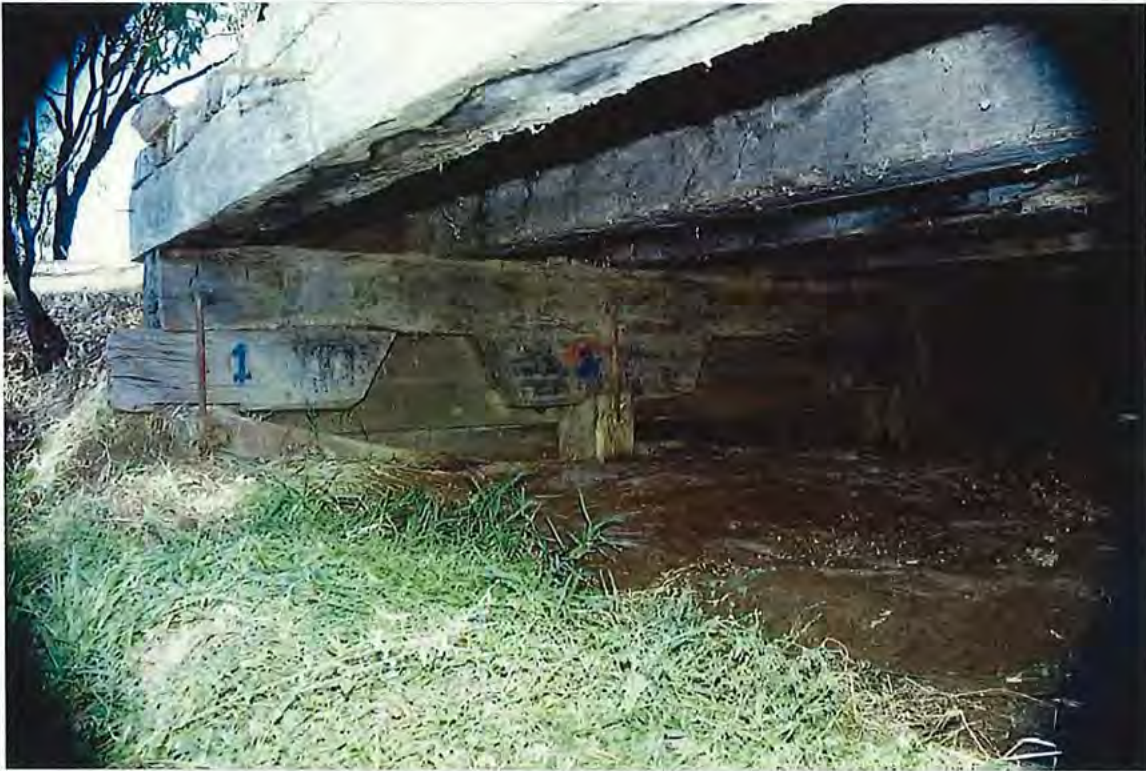
ABUTMENT 2 LEFT HAND SIDE LAYOUT FROM LEFT HAND SIDE ABUT 1
