Shire of  
**Narrogin**  
*Love the life*

## BRIDGES ASSET MANAGEMENT PLAN

2020-2030

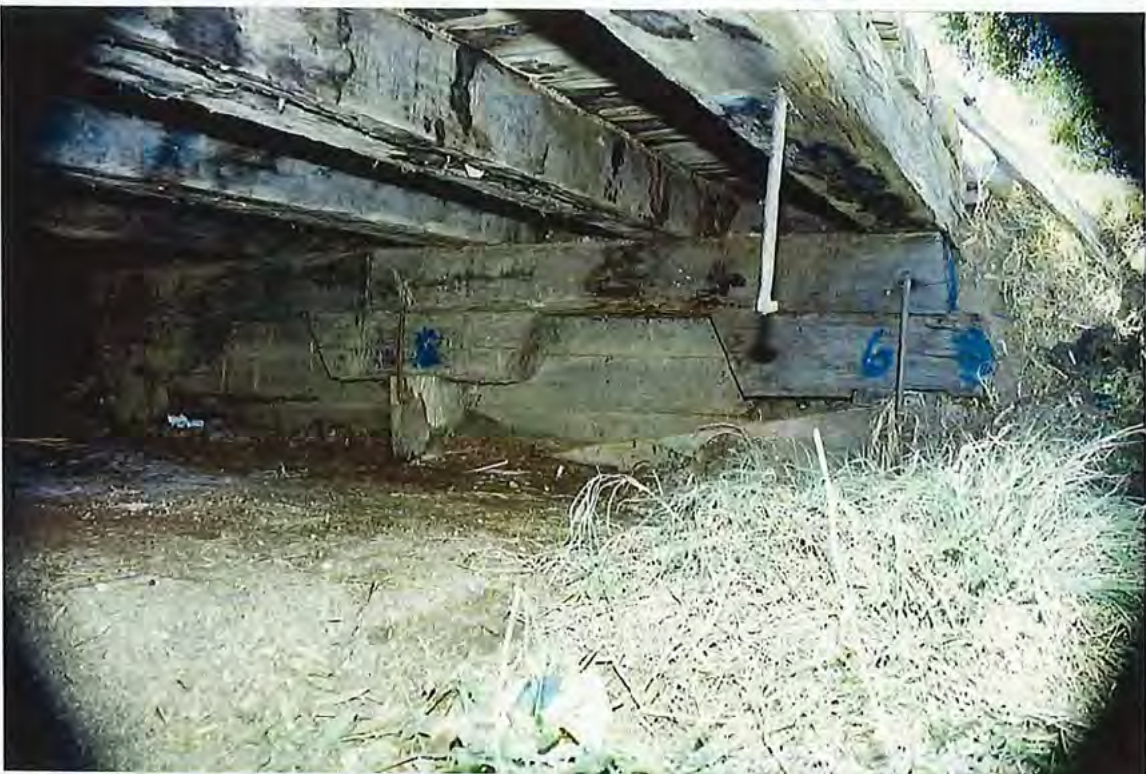
ABUTMENT 2 RIGHT HAND SIDE LAYOUT FROM RIGHT HAND SIDE  
ABUTMENT 1

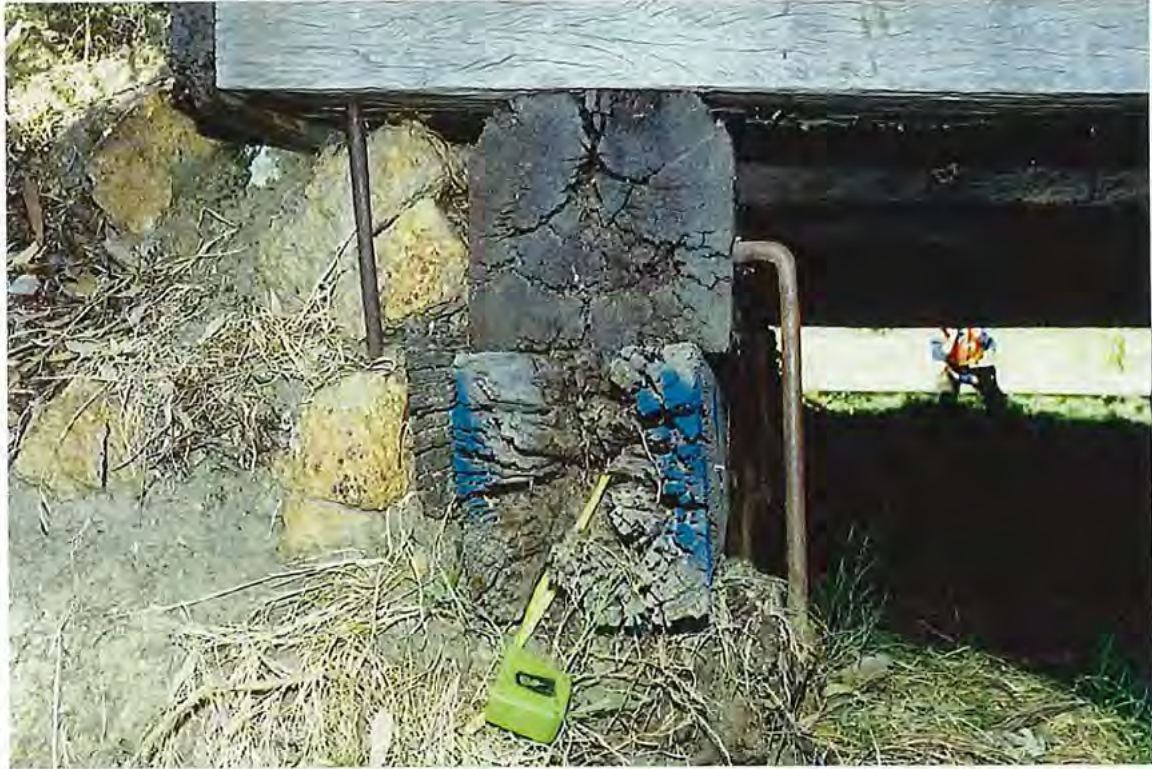
ABUTMENT 2 LEFT HAND SIDE FULL CAP & CORBEL 1 CONDITION

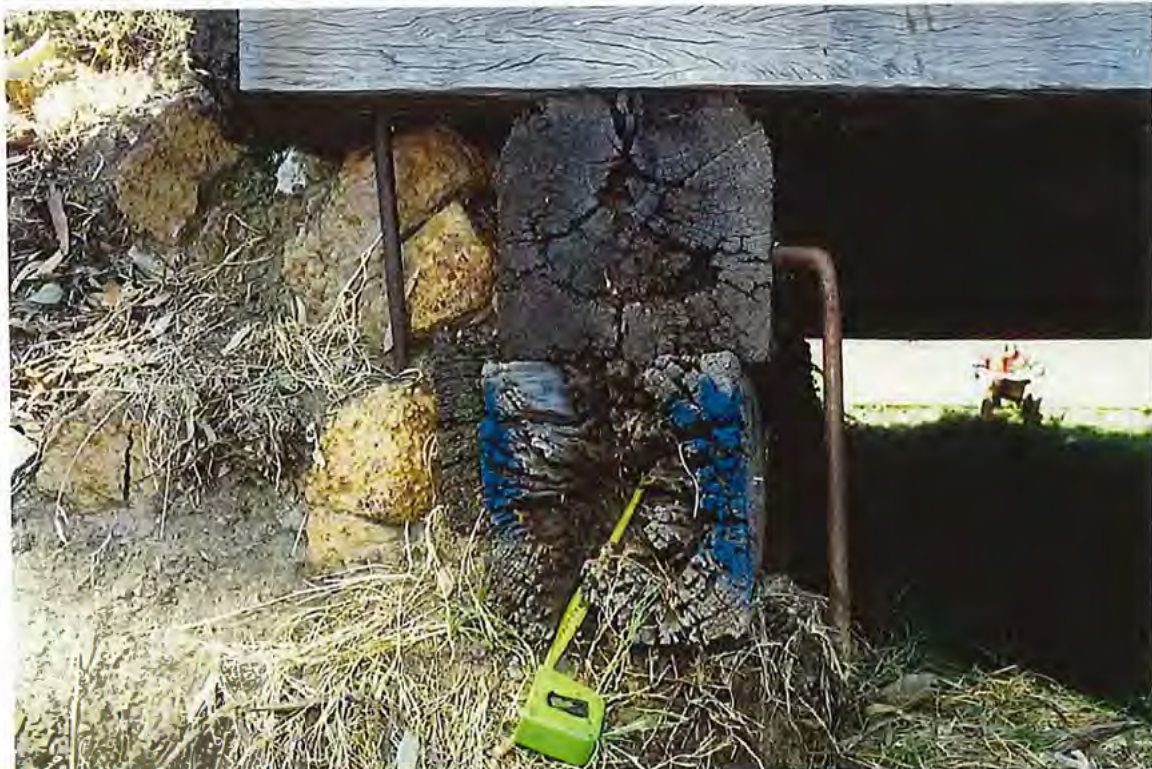
ABUTMENT 2 LEFT HAND SIDE FULL CAP & CORBEL 1 CONDITION

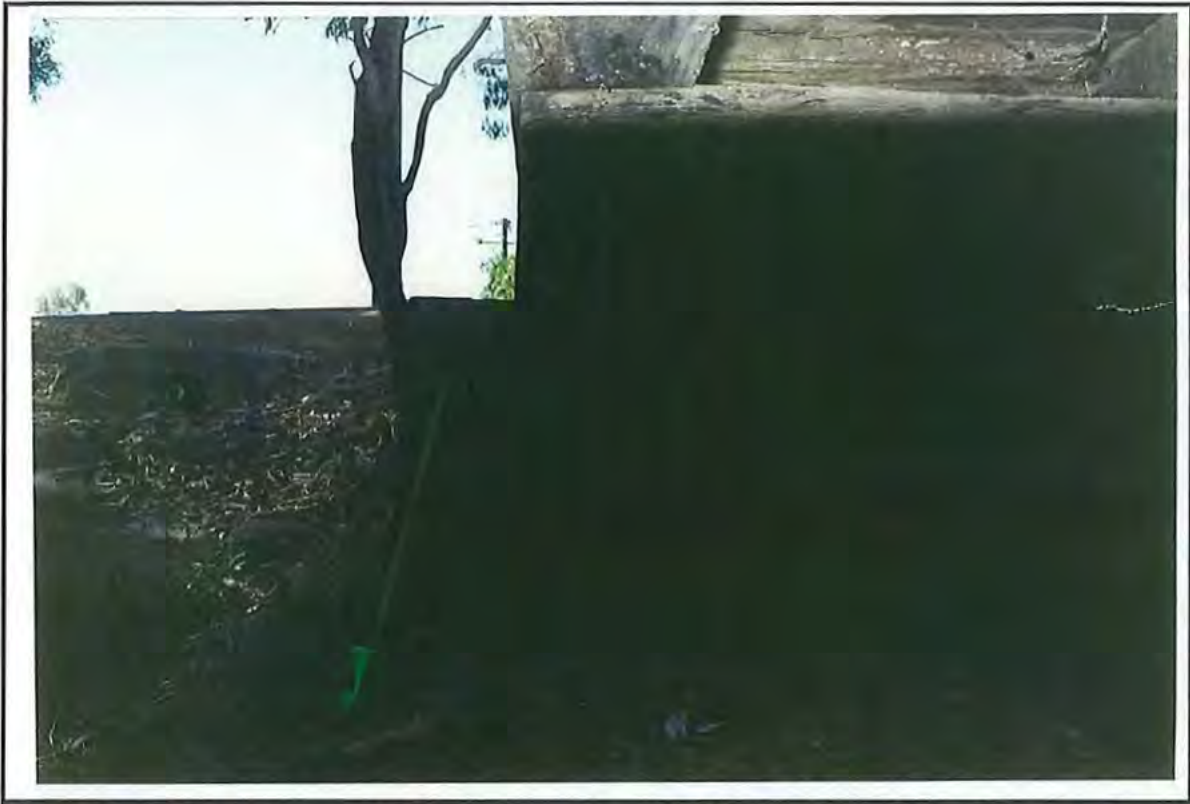
ABUTMENT 2 LEFT HAND SIDE FULL CAP & CORBEL FRONT VIEW – NB END OF BRACING TYPICAL

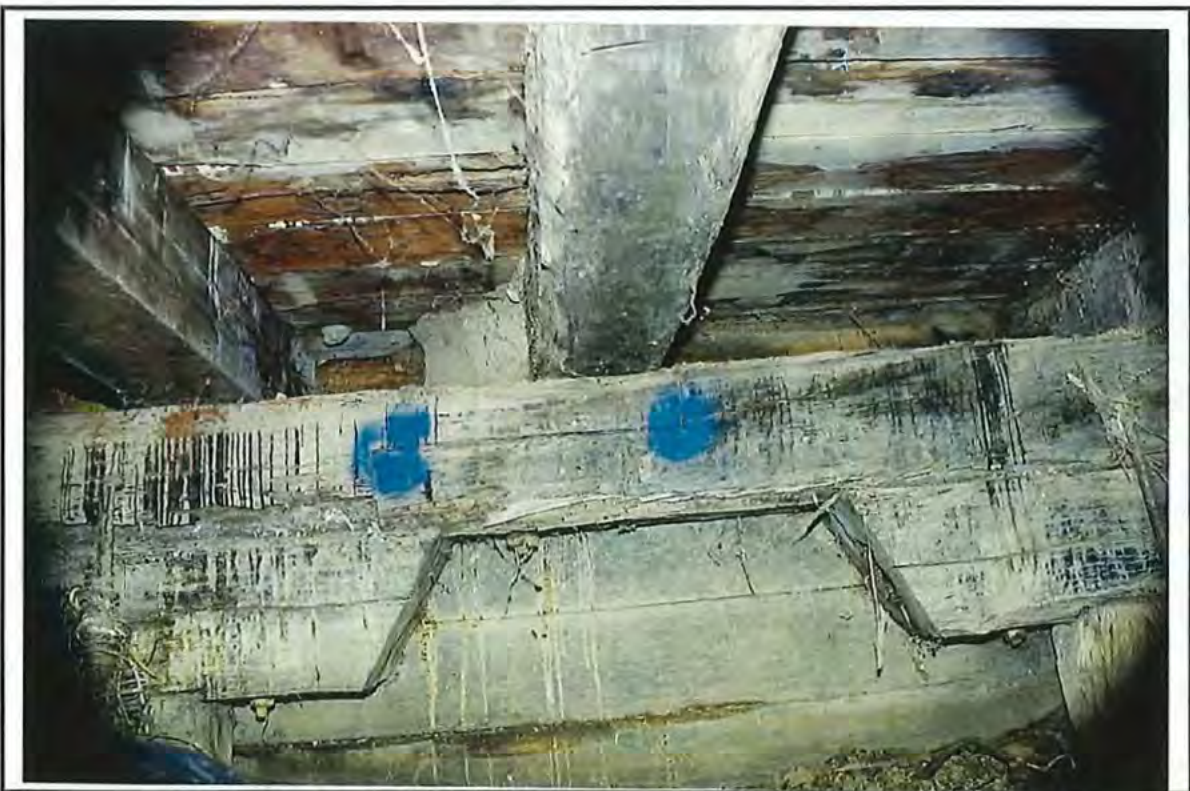
ABUTMENT 2 FULL CAP CONDITION BELOW STRINGERS 7, 8 & 9

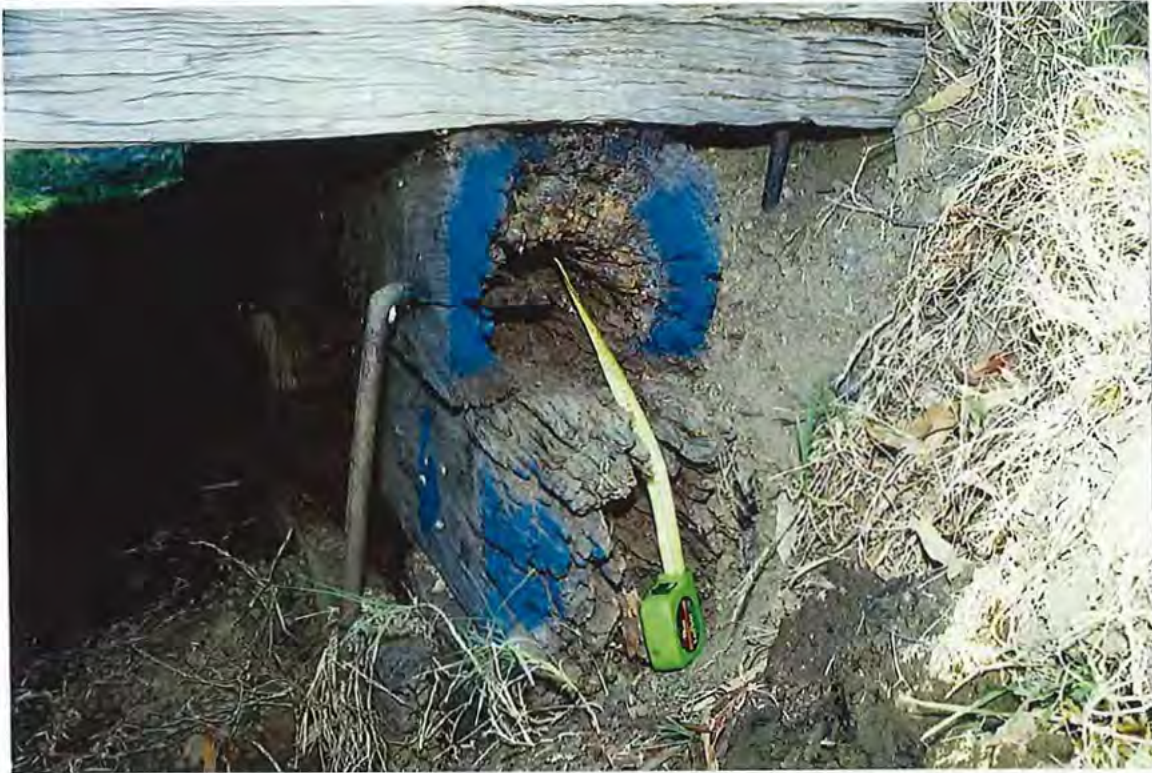
ABUTMENT 2 RIGHT HAND SIDE END FULL CAP & CORBEL 6 CONDITION

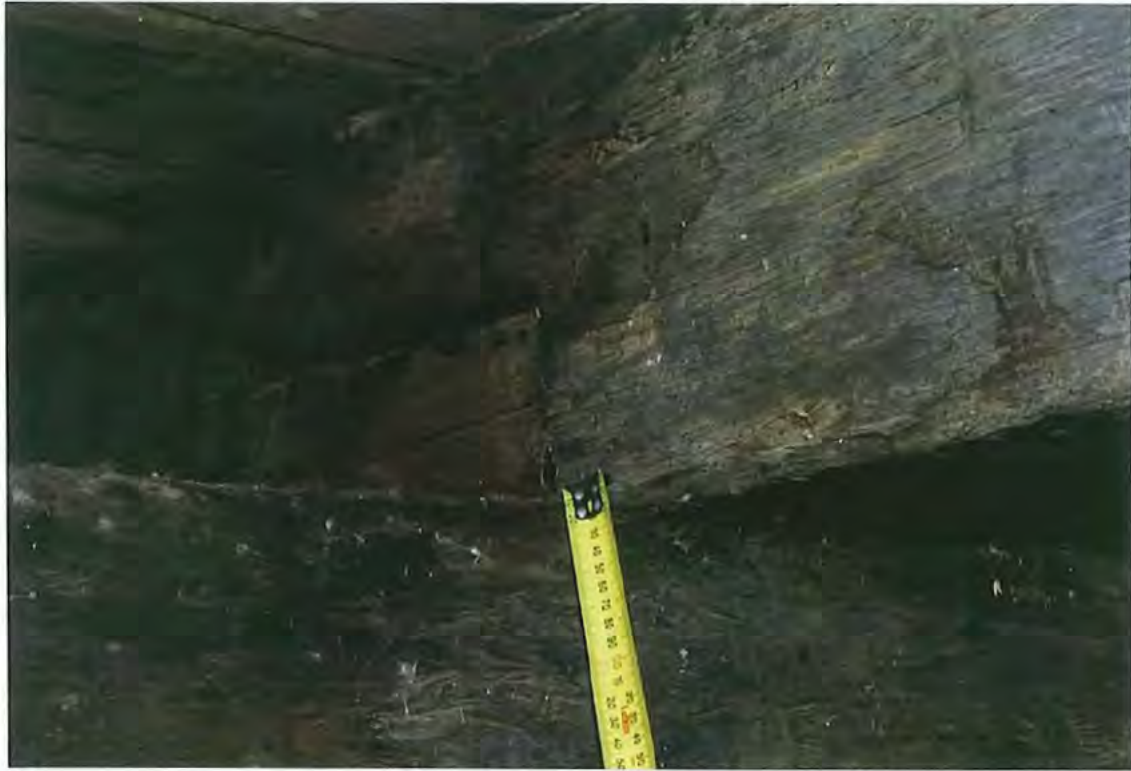
STRINGER OVERLAPS TYPICAL
